May 20, 2008

Re: Historic Railroad Depot
Belleville BUILD 2007 - Implementation
Architectural Feasibility Review
MSA Project No. 3720706B

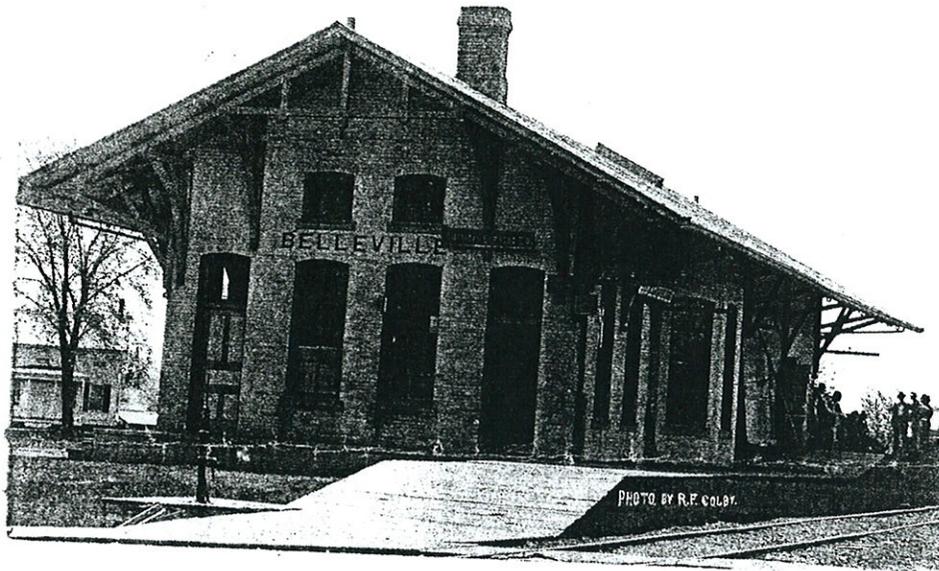
The existing building is in a deteriorated, but salvageable condition. The historic nature and location of the building make it priceless and worth restoring. See Photo #1 for a historic photo of the building exterior. See Photo #2 for a current photo of the Depot.

Photo #1 – Historic Photo of the Depot.

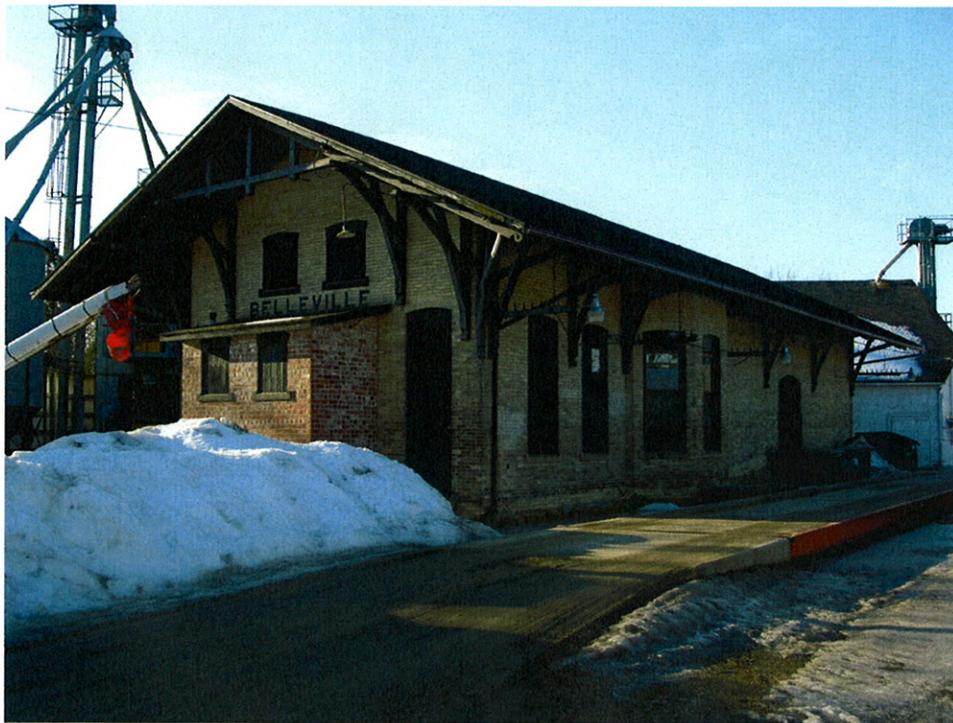
Photo #2 – Current day photo of the Depot.

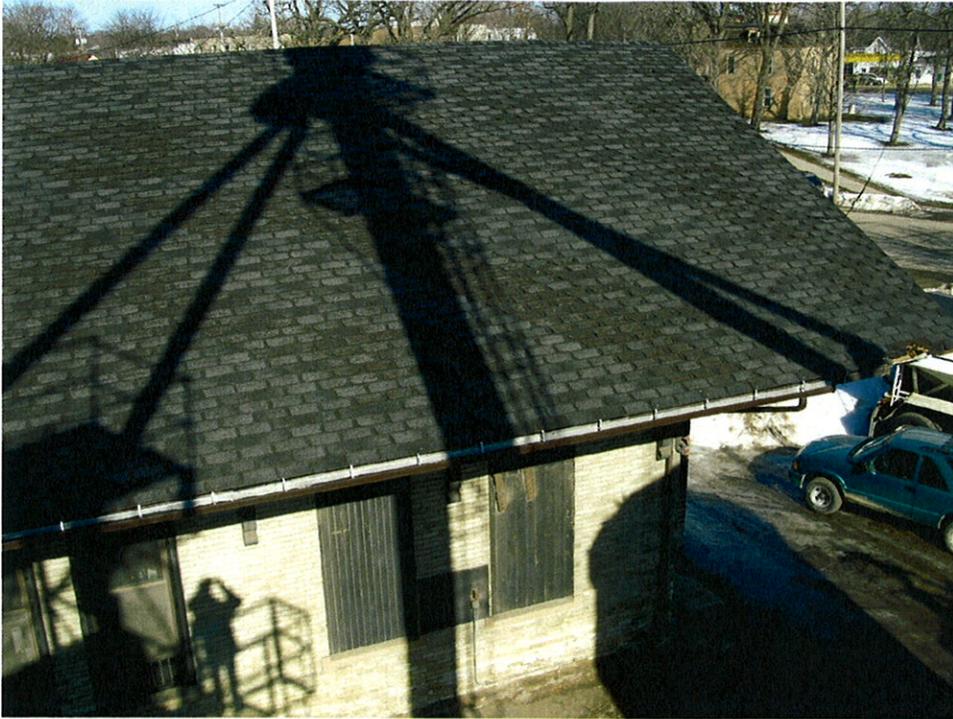
2. Roof: The shingles are in poor condition and need to be removed and replaced. See Photo #3. There are two skylights that were added and should be removed and closed up. Miscellaneous roof sheathing boards will need to be replaced.

Photo #3 – Shingles in poor condition.

10. Roof:
 - a. Remove all existing roofing materials down to deck.
 - b. Remove and replace areas of decking that are damaged. Deck at eaves must have bead board on underside of eave to match existing design.
 - c. Remove and close up existing sky lights.
 - d. Extend roof deck at South end of building to match the north end. See the proposed plan.
 - e. Build new brackets for new roof edge.
 - f. Replace damaged fascia to match existing.
 - g. Remove exiting gutters and downspouts.
 - h. Install new gutters and downs spouts with historically similar gutters and downspouts.

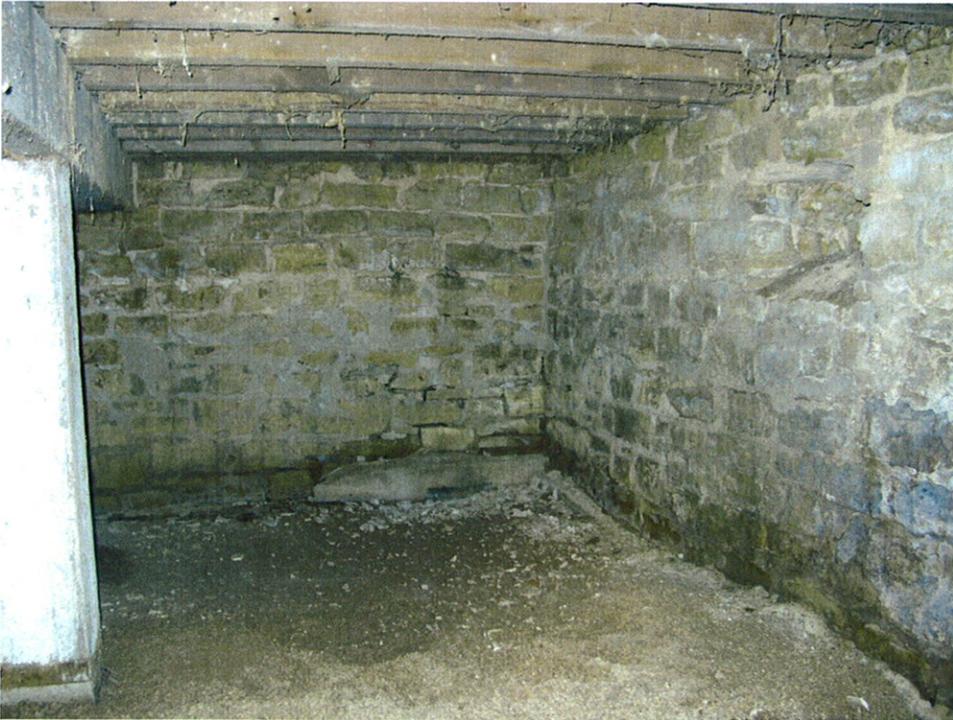
4. Interior Wall Surface: There is plaster on some of the ceilings and walls. All must be removed due to water damage and old age.
5. Basement: There is a deep crawl space under the entire building. It is not a true basement due to the limited headroom. The ceiling height varies from five to six feet under the beams. There is what appears to be a concrete floor. The stone rubble foundation walls leak. This space needs to be cleaned if the basement is to be used for storage. There is only one entrance to the basement from the exterior. There is no interior stairs. See Photo #4.

Photo #4 – Basement.

3. Basement:
 - a. Clean basement.
 - b. Remove existing access door. Construct a new poured in place concrete foundation and stair with an access hatch.
 - c. Remove the entire concrete floor.
 - d. Excavate approximately a 16'x16' area in the basement to allow an 8' clearance to the underside of the lowest structure.
 - e. Pour concrete 'knee walls' with footing to retain surrounding soil.
 - f. Pour 16'x16' x 4" slab over 6" gravel over vapor barrier.
 - g. Frame insulated wall on top of concrete walls to keep the new space clean and relatively dust free and warm.
 - h. Provide access door to remainder of basement.
 - i. Pour a new concrete floor in the entire basement.
 - j. Infill the existing foundation vents.
 - k. Repair deteriorated areas of the existing foundation wall and floor framing.

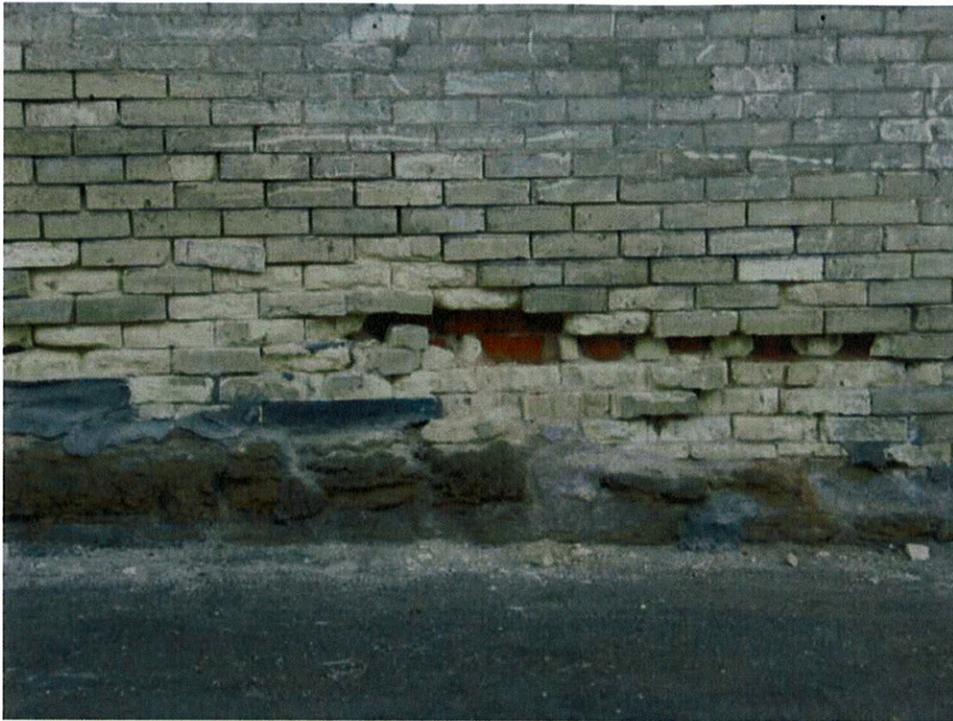
9. Brick Exterior: There are areas that need to be replaced. Tuck-pointing will also be required. See Photo #5.
10. Foundation Wall: The foundation is a stone wall. The area above grade is very deteriorated and needs to be repaired.

Photo #5 – Exterior brick wall and stone foundation.

4. Foundation wall:
 - a. Excavate entire exterior perimeter full the full height of the foundation wall.
 - b. Repair and tuck-point foundation wall.
 - c. Install drain tile and a sump with a pump.
 - d. Damp proof the foundation wall.
 - e. Install rigid insulation to 4' below grade at out side face of wall.
 - f. Backfill the foundation.

5. Brick:
 - a. Replace damaged and deteriorated brick with new material to match existing brick.
 - b. Tuck point the entire exterior wall surface of the existing brick and stone sills.

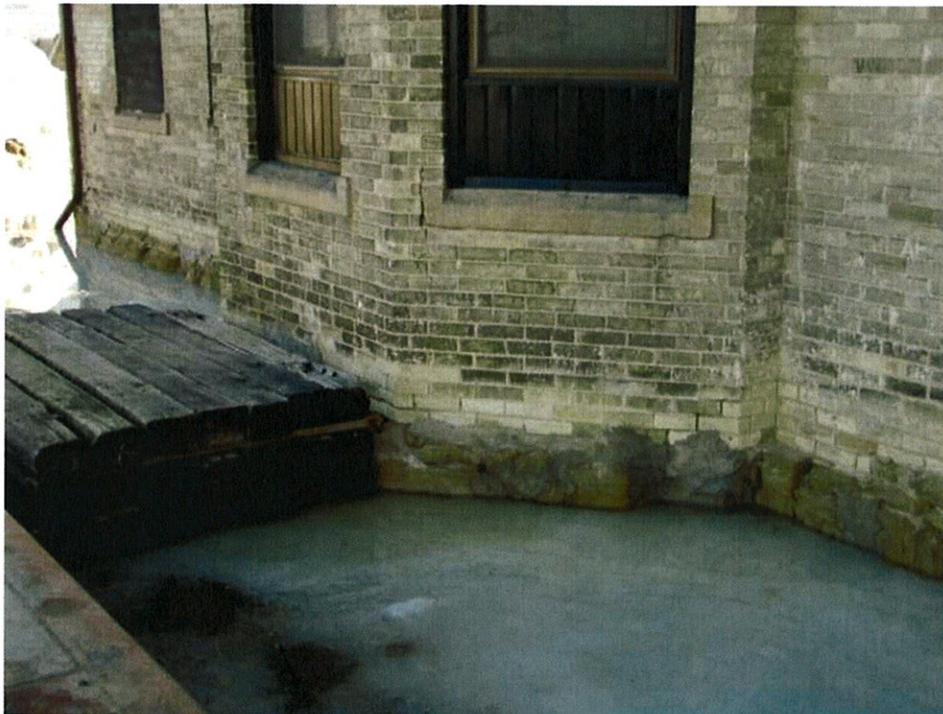
11. Finished Grade: Poor drainage is a problem at three of the four sides of the building. Fill needs to be added and the site re-graded to get the site to drain surface water away from the building. See Photo #6.

Photo #6 – Poor drainage around the building causes water to pond.

2. Site and grading:
 - a. Raise grade around the building perimeter about 10". Re-grade so there is positive drainage away from the building.
 - b. Construct a new asphalt paved parking lot on the east side of the building.
 - c. Install landscaping consisting of trees and shrubs.

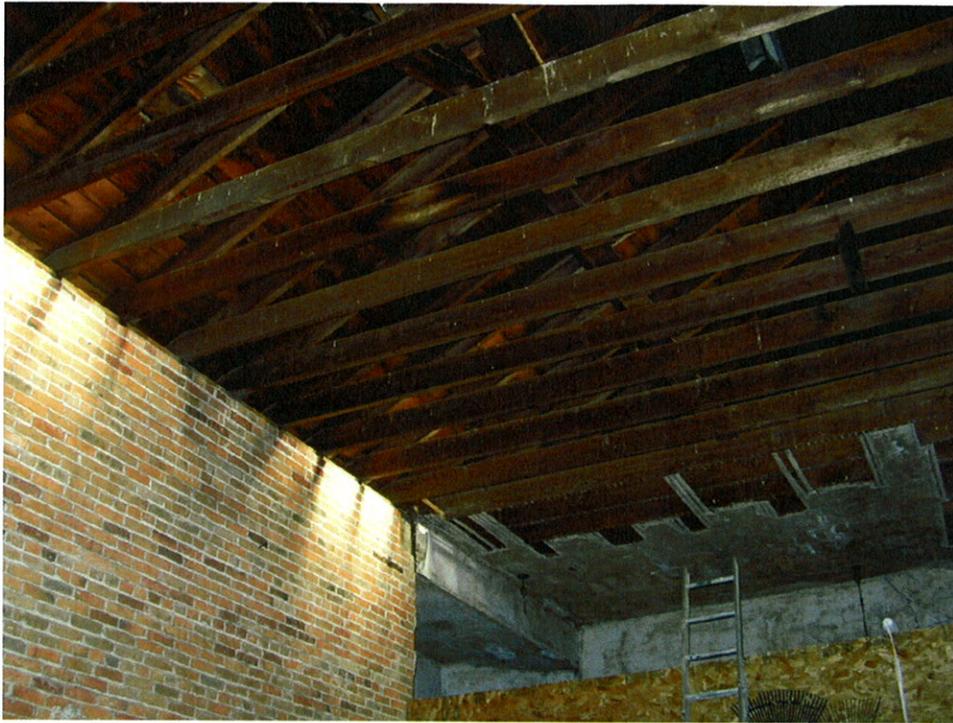
Condition: The interior wood roof planks exhibited staining from water infiltration. The wood roof framing was exposed above the southern portion of the building where the ceiling construction was removed (old freight receiving area), and the roof framing was accessible for a small region above the current office space ceiling. The wood framing and wood planks in the accessible region were in good condition with no visible signs of deterioration or distress. See Photo #7. The condition of the exterior roof system ranged from good to deteriorated. Typically, the edge condition near the eaves exhibited deteriorated wood soffit panels, deteriorated wood fascia, deteriorated wood planks, and deteriorated wood bracket parts. See Photo #8. Typically, the exterior framing near the exterior walls was in good condition.

Photo #7 – Wood roof framing in good condition.

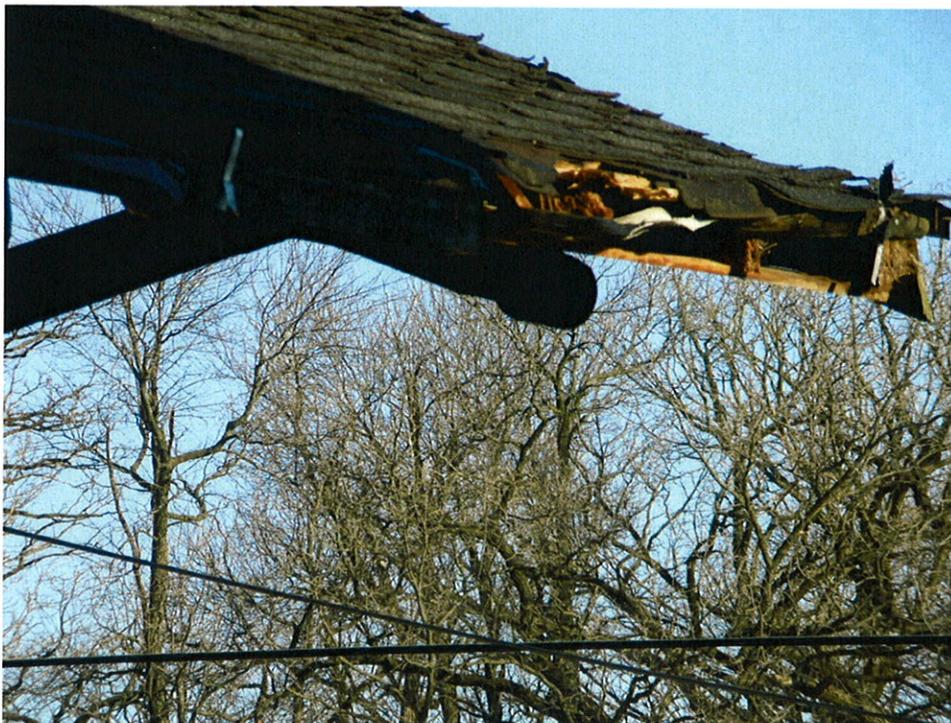
Photo #8 – Damaged overhang needs repair

9. Wooden Brackets:
 - a. Remove and repair damaged wooden brackets.
 - b. Replace with new brackets where old brackets have failed and are no longer structurally effective.
 - c. Clean old paint off of brackets, treat brackets with a fungicide to eliminate rot, and apply new coats of paint.
 - d. Old wooden wire racks shall remain. Find historical insulators to install on the racks.

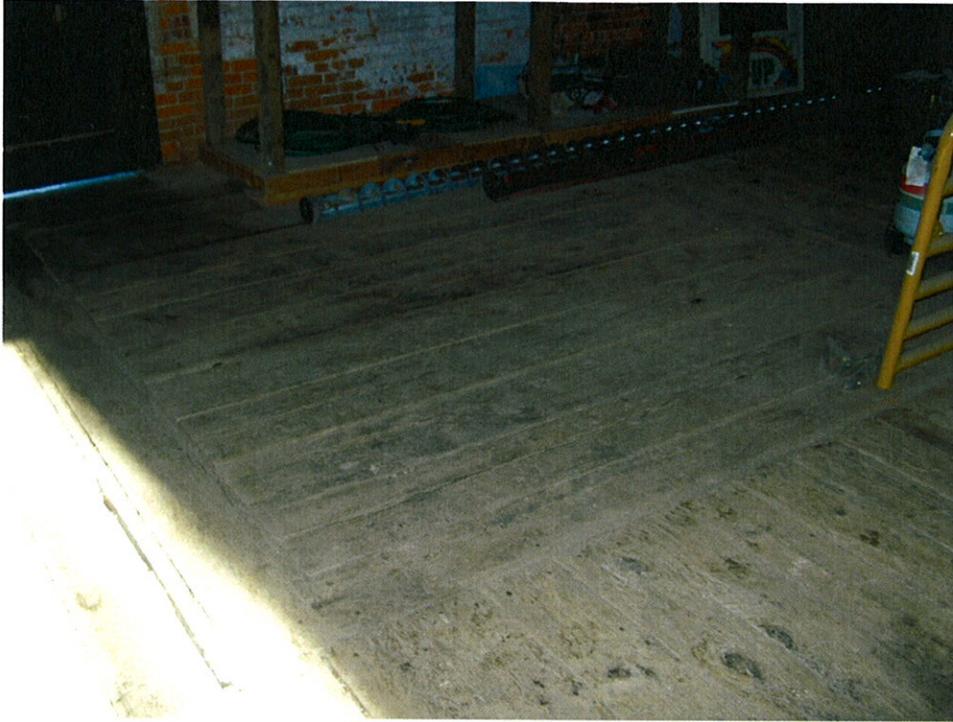
The floor framing consists of wood planks, see Photo #9, (approximately 3½" thick within old freight receiving area) on 3x12 wood joists spanning 12'-0" at 16" on center. The joists rest on 12"x12" wood girders spanning 8'-0" between 12"x12" wood columns and the exterior foundation walls. The level of the floor framing is lower at the old passenger waiting area and higher at the old freight receiving area. Various miscellaneous framing modifications were observed particularly near the middle of the building where posts were installed as supplemental supports. A second layer of floor framing was installed above the original construction beneath the current office area, which extends the upper level of the floor framing further to the north.

Photo #9 – Existing wood plank floor in good condition.

11. Interior floor:
 - a. Clean the existing wood floor with a chemical deck wash/cleaner. Seal the wood to left as the exposed floor surface.
 - b. In the toilet rooms, install a cementitious overlay on the wood floor to receive ceramic tile.
 - c. Frame in area over 'lower floor' to make it level with the existing floor. Use wood framing and wood decking that is similar to the existing deck.

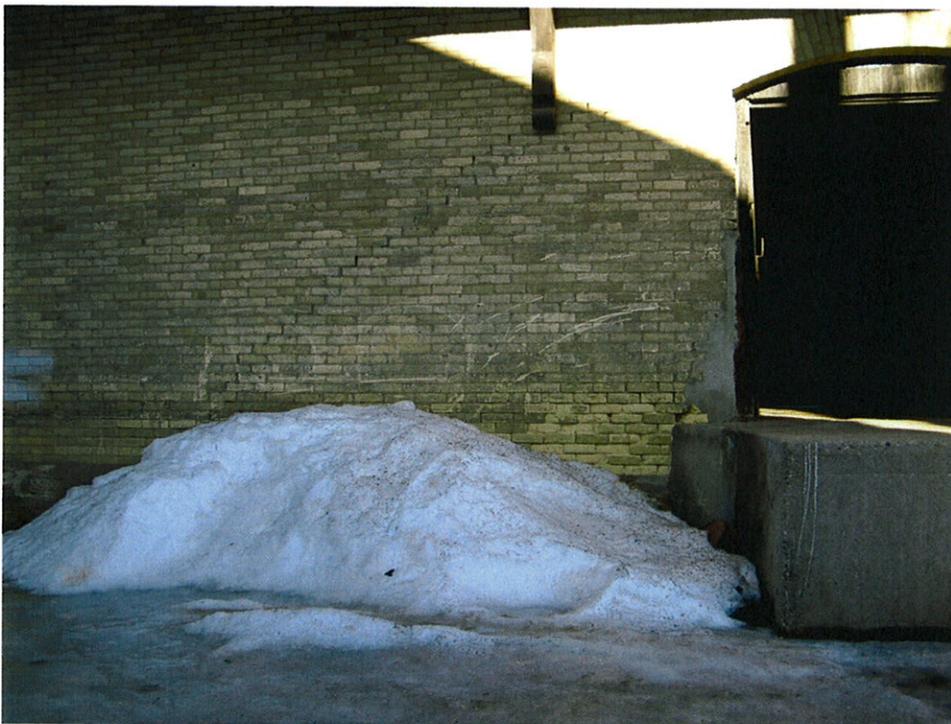
Condition: The exterior side of the brick wall near the base and the top of the foundation wall was deteriorated on the east and west sides of the building. The most severe conditions were concentrated toward the middle portion of the building, but smaller spalls, cracks, and loose mortar sections extended throughout the entire length.

A few diagonal and a few vertical cracks were observed on the interior and the exterior faces of the wall. See Photo #10. The cracks extended nearly the full height of the wall. The south wall was repaired in the past with new brick that does not match the surrounding construction. The mortar between stone pieces within the basement was missing particularly near the base. Water infiltration and freezing was observed at a wall opening on the west side, which appeared to be the former coal-shoot.

Photo #10 – Cracks and deterioration in the exterior brick wall.
