MUNICIPAL STUDY  
**VILLAGE OF BELLEVILLE,  
WISCONSIN**

SEPTEMBER 17, 2015

**FEH DESIGN**

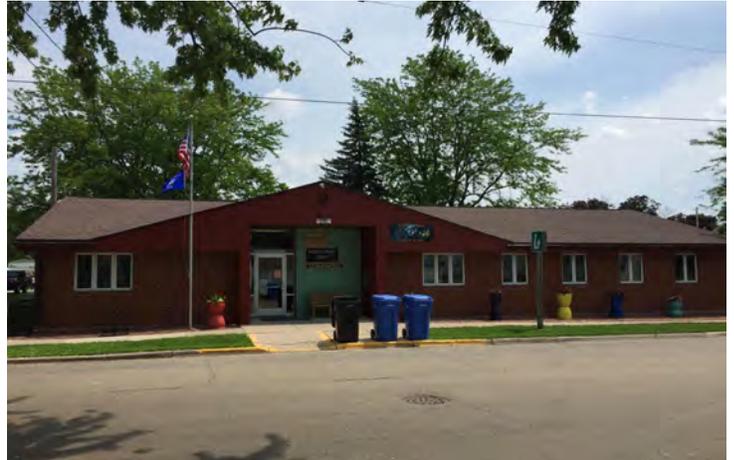
The library, pictured, was built in 1978. Since its construction, significant updates have been made to the building in order to maintain this community resource. A new roof was added in 1994 and 2006, new flooring was installed in 2003, new doors and gutters were added in 2004, major elevator repairs were made in 2012, new ADA bathrooms were created in 2012, the exterior was painted in 2014, and a new HVAC system was provided in 2015. The library is

noncombustible construction of a single story building with basement constructed of brick, concrete block, and siding with a shingle roof. The library currently shares space with the Sugar River Senior Center, which is in the process of relocation. The overall library building is 6,412sf and the overall site is 18,774sf (0.431 acres) with 10 parking spaces, one of which is accessible.

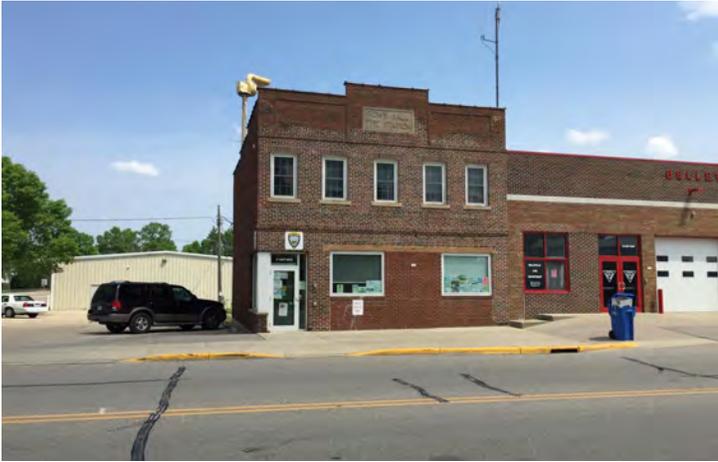
The police station, pictured, is a historic building that has had some improvements in the recent past including a new roof in 1992, a upper level remodel and furnace replacement in 2007, a front entry ADA remodel in 2012, and a general remodel including windows, finishes, and electrical work in 2013. The building is three stories of noncombustible construction, including a lower level, constructed of masonry walls with a low-slope roof and concrete structure. The
