3ND ANNUAL MONITORING REPORT
FOR THE
LAKE BELLE VIEW RESTORATION PROJECT

BELLEVILLE, WISCONSIN

FEBRUARY 2014

Two Year Evaluation

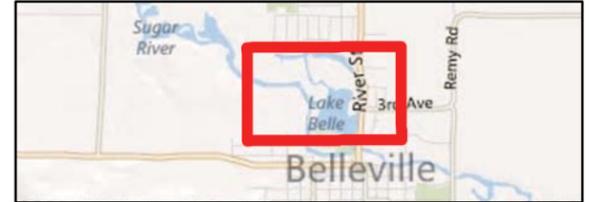
SHEET NO.
Figure 1

Main Map Projection: Dane County Coordinate System | Locator Map Not to Scale

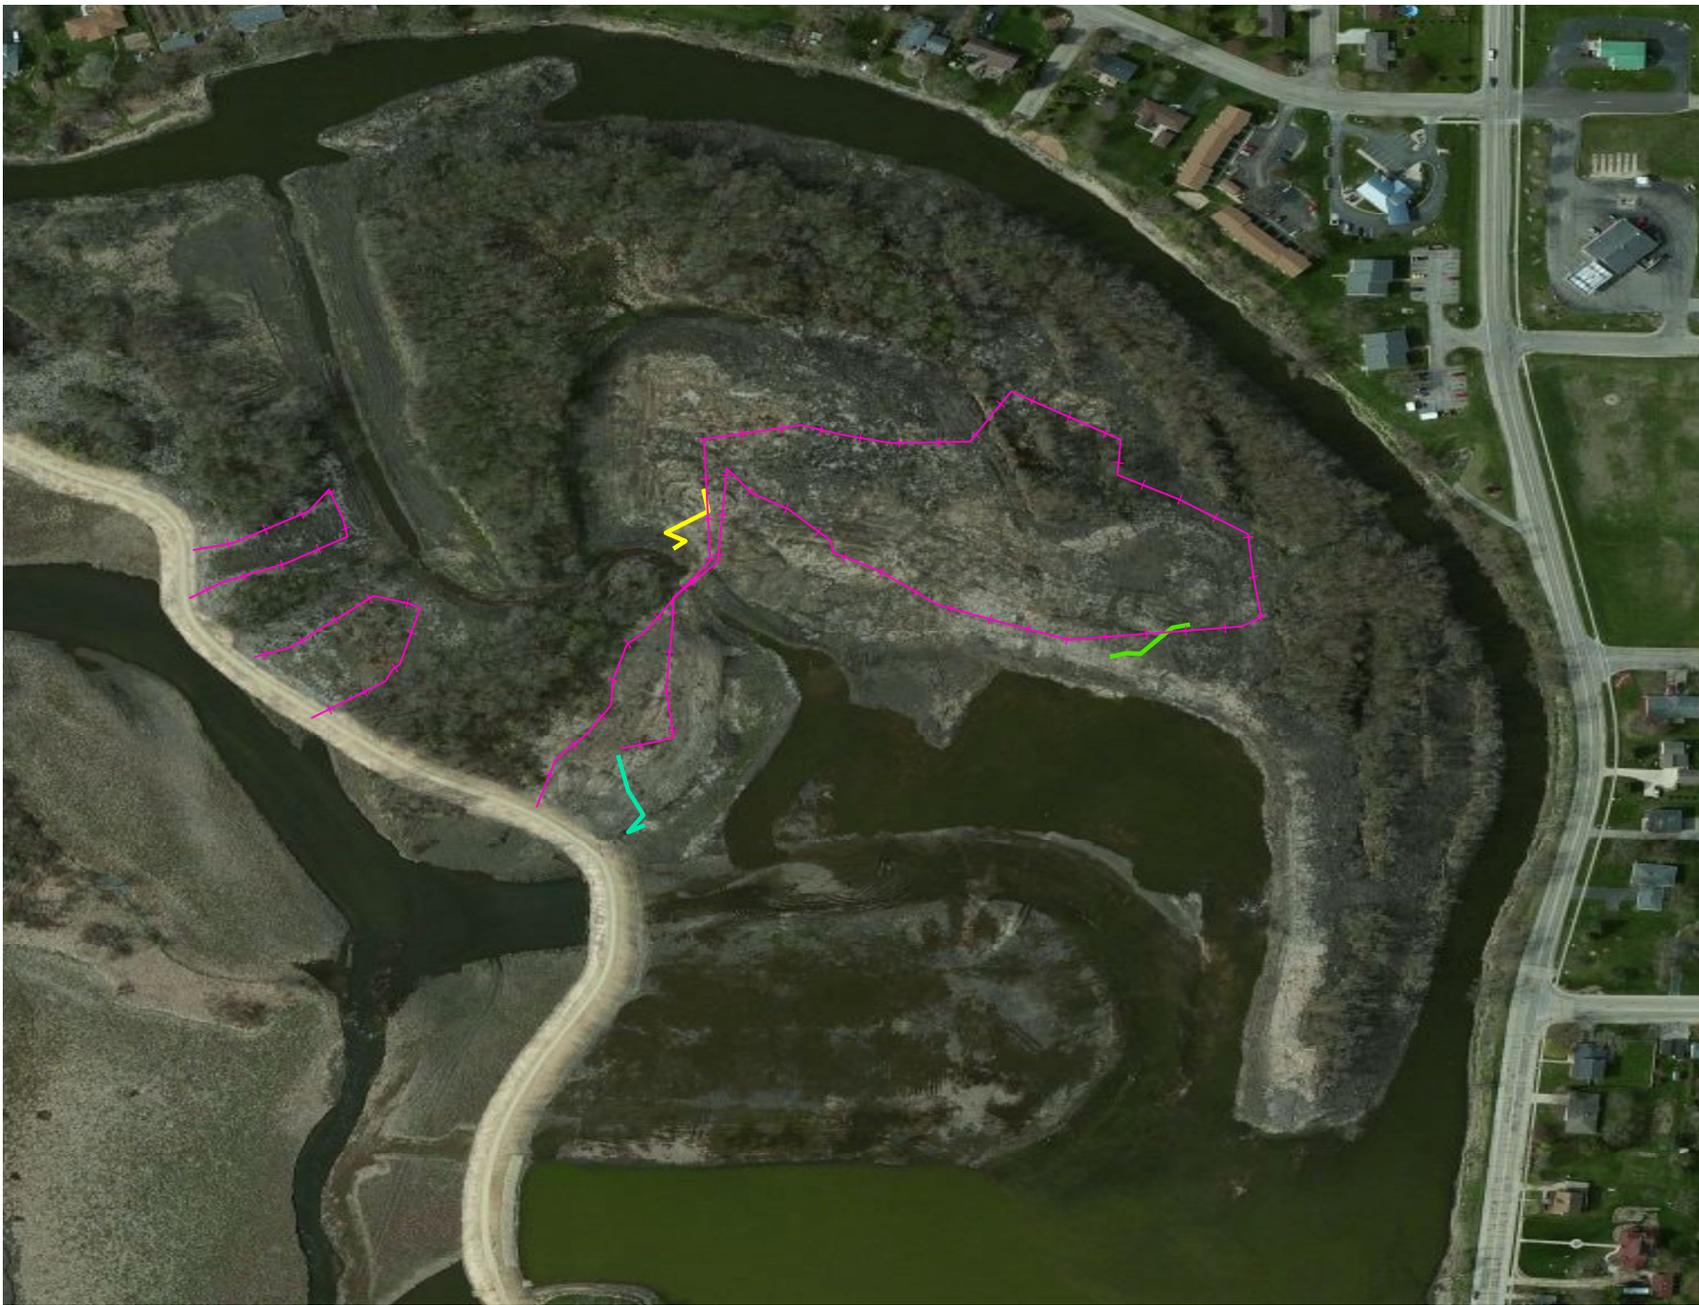
Summer 2013 Meander Survey
Paths and Transects
Lake Belle View Lake Restoration
Village of Belleville
Dane County, WI

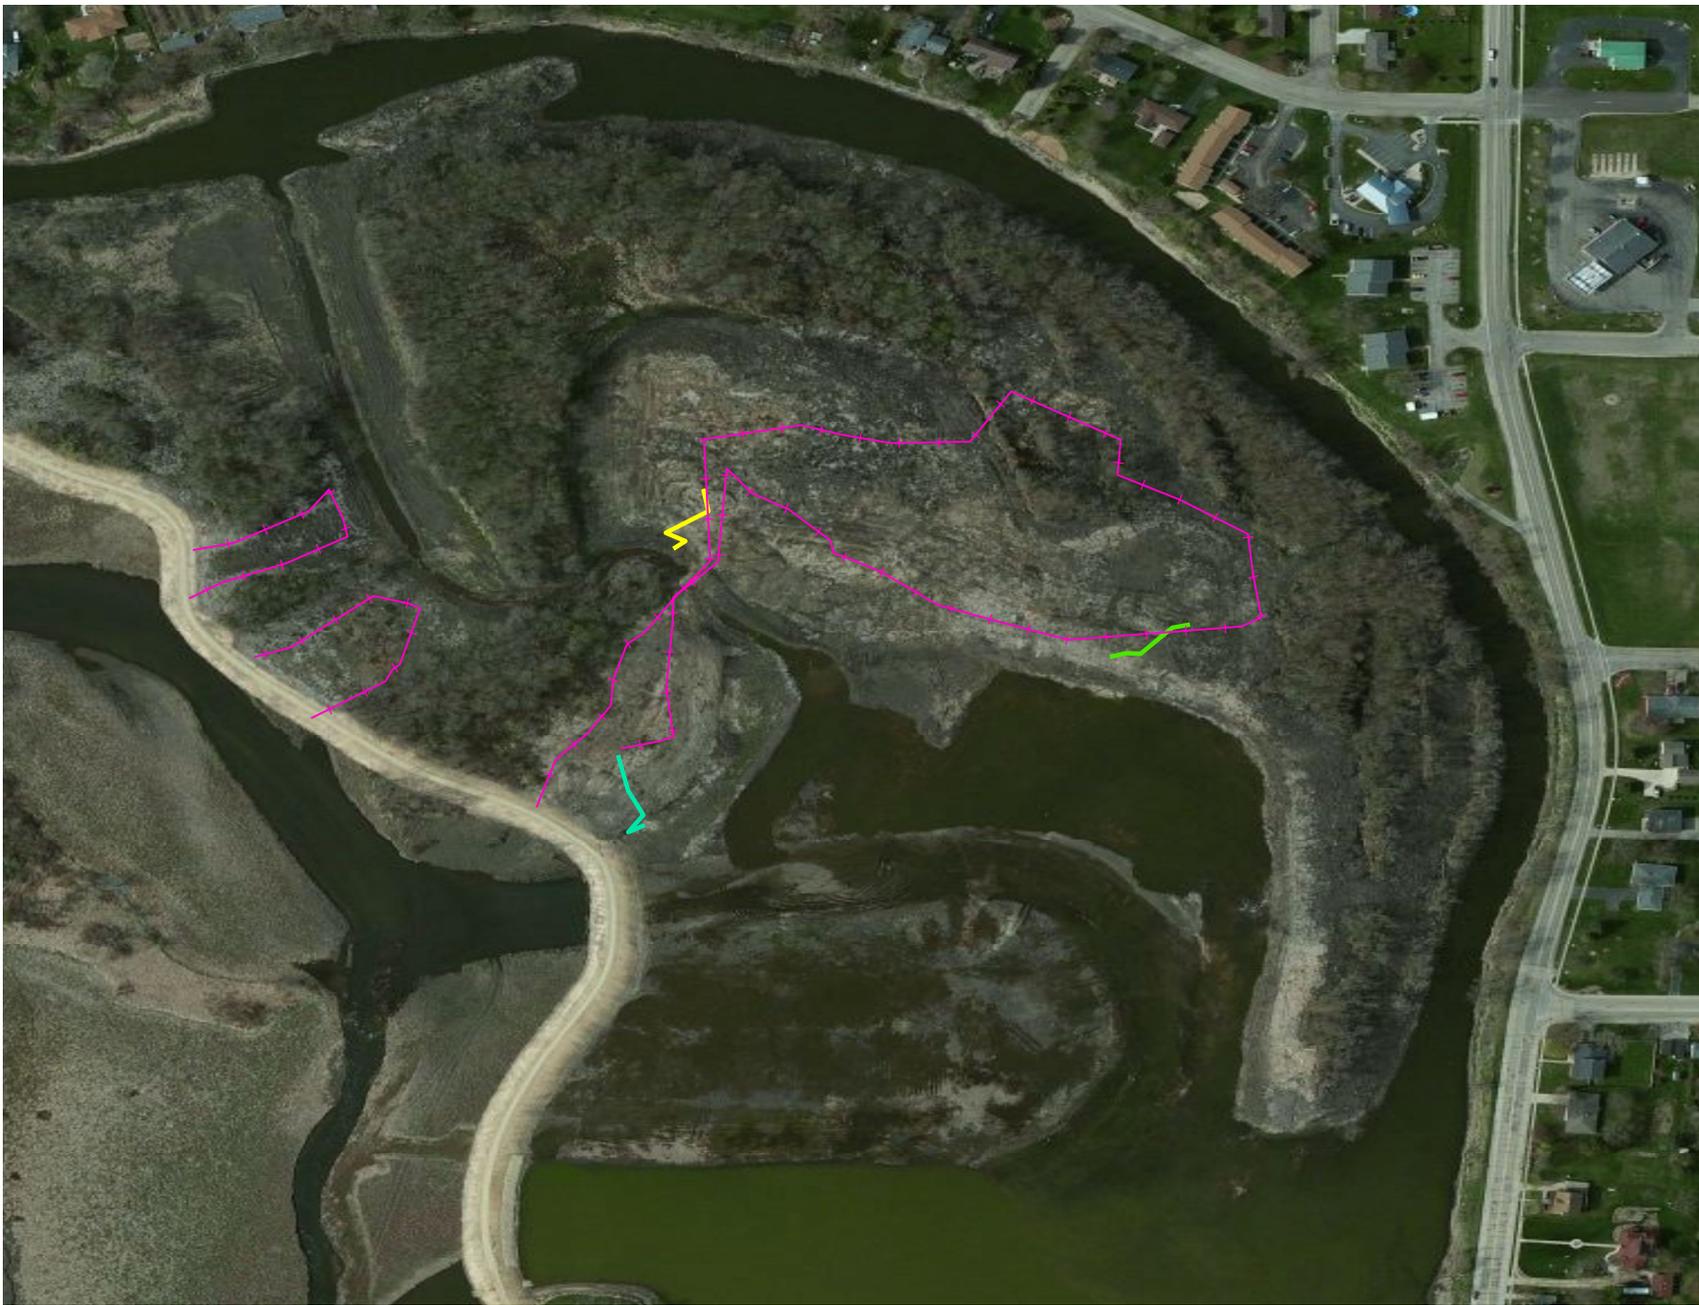
Summer 2013 Meander Survey
 Paths and Transects
 Lake Belle View Lake Restoration
 Village of Belleville
 Dane County, WI

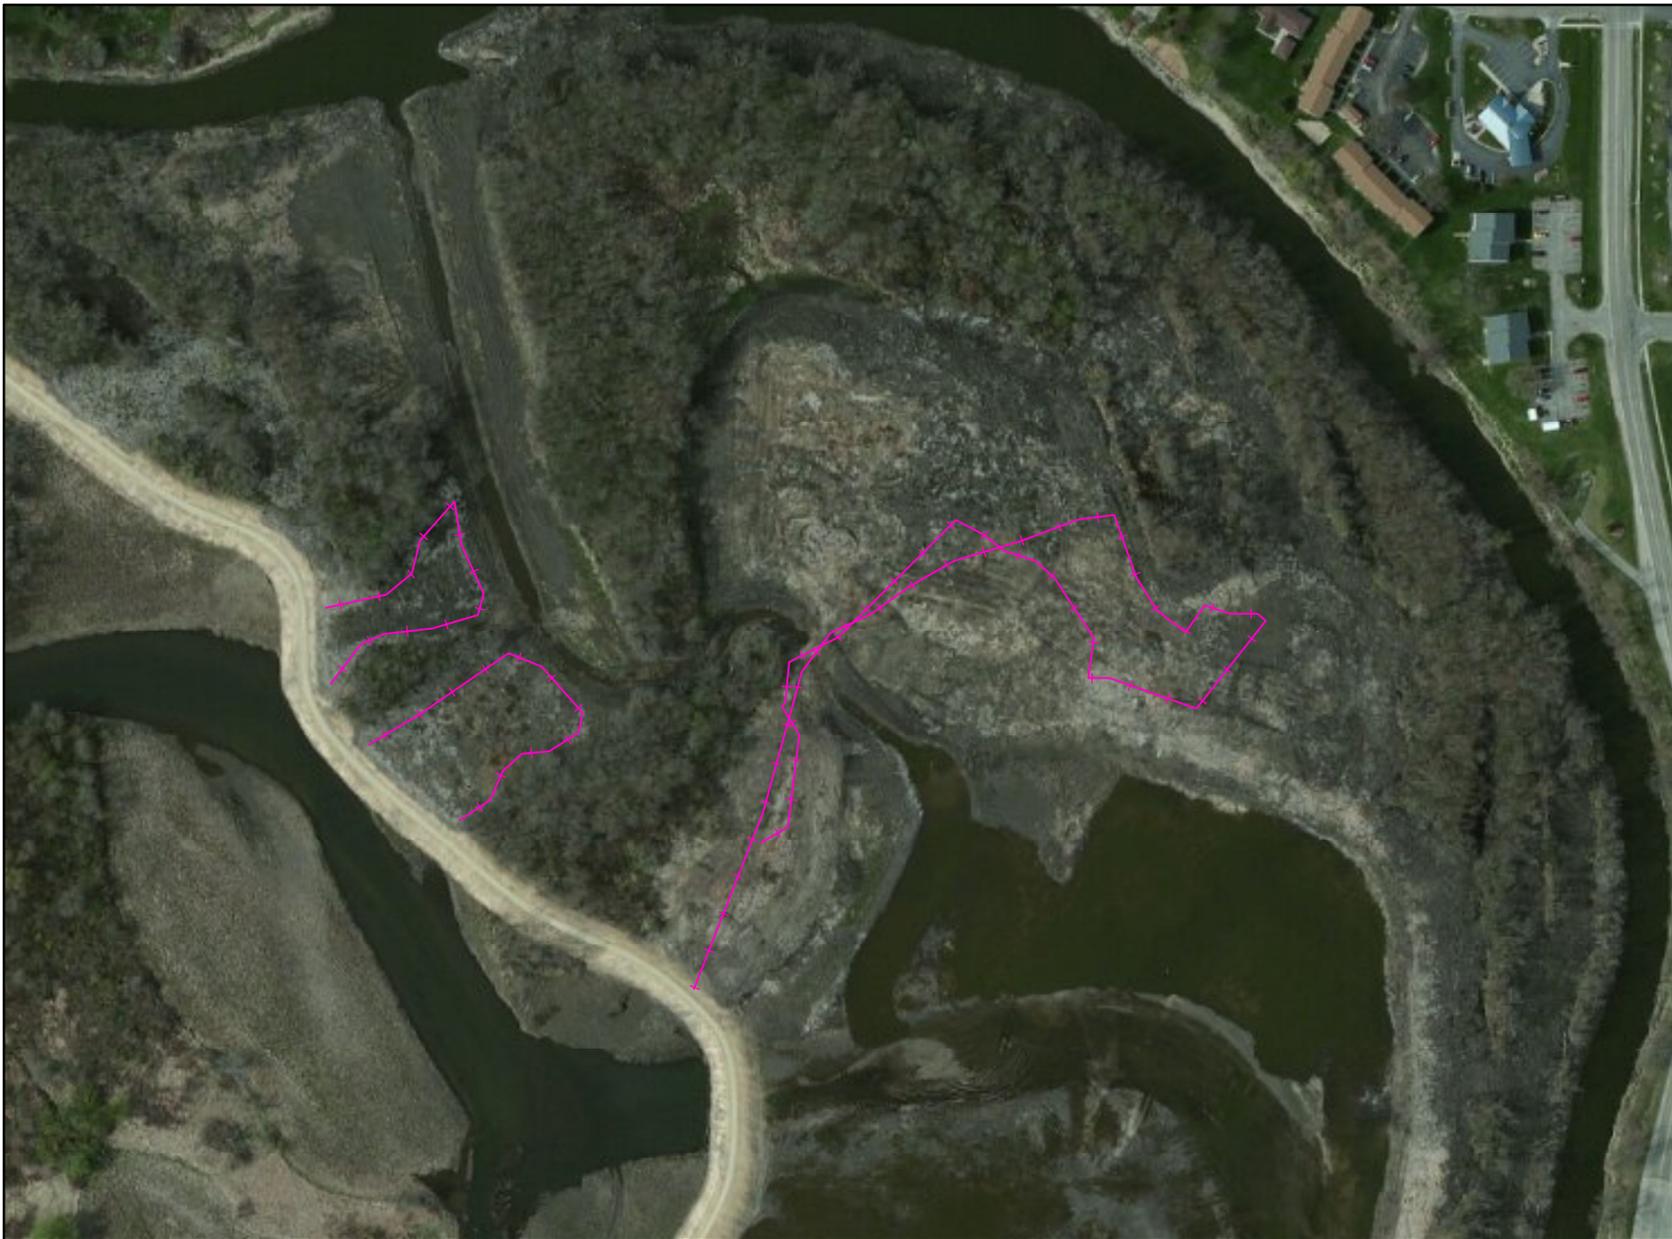
Meander Survey
