MUNICIPAL STUDY  
**VILLAGE OF BELLEVILLE,  
WISCONSIN**

SEPTEMBER 17, 2015

**FEH DESIGN**

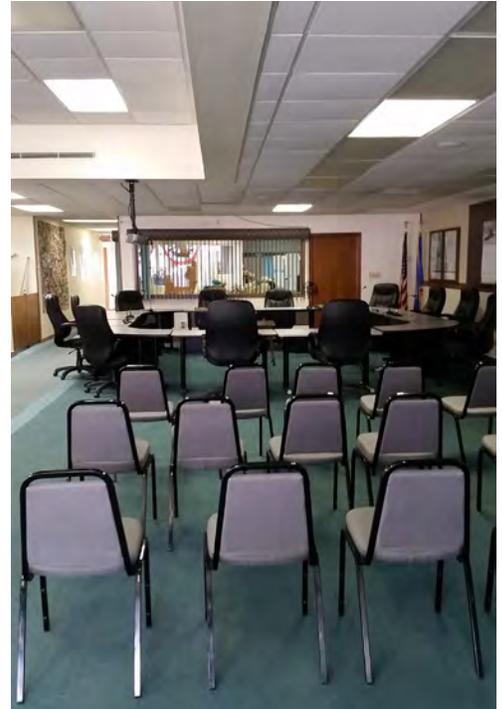
The exterior of the building appears to be in good repair, with few immediate maintenance needs. The second floor of the original building is vacant and outfitted as a residence. Significant work would be needed to convert the second floor to office space with regards to access and wall locations. The number of bathrooms (2) is insufficient for the number of occupants of the building when including the assembly spaces. Offices and meeting space are located on the first floor and staff spaces and storage are located in the basement.

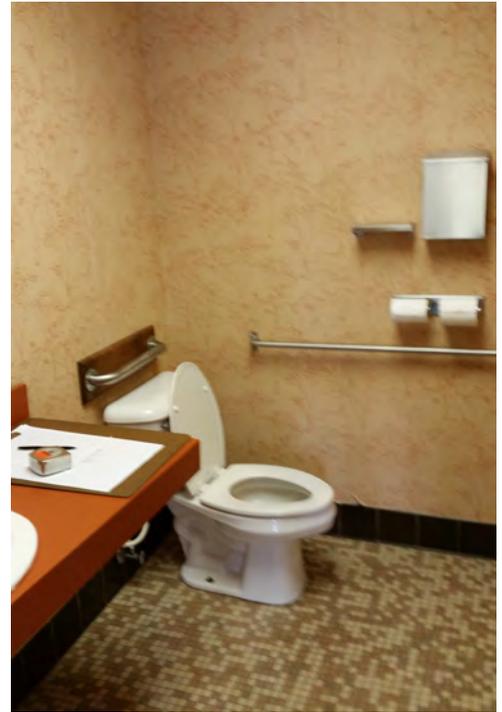
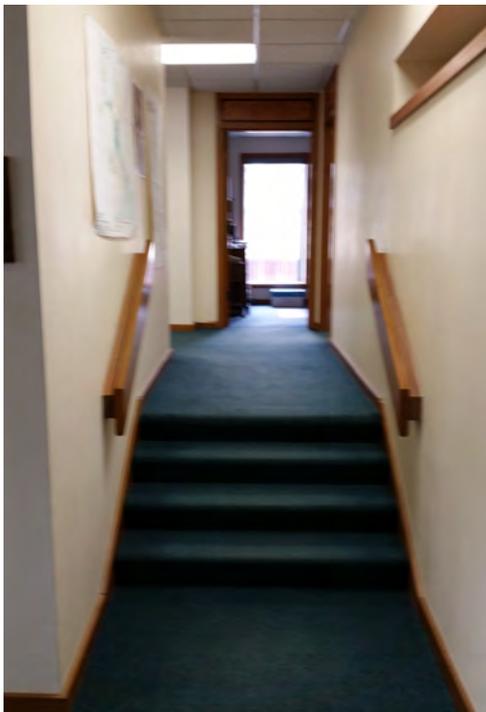
The door hardware on all the interior doors should be converted from knobs to levers. The bathrooms are not currently accessible, requiring the proper clearances around fixtures, accessible-height toilets, grab bars, and clear space on the pull side of the doors. The doors into records are not accessible and, if only used by staff, need not be revised. The offices are on a raised section of the first floor. A lift should be provided for access to these spaces, a center handrail should be added at the wide stairs, and the handrails should be revised for graspability and to have the proper extensions. Neither the upper level nor the basement are accessible, without elevator access and without general maneuverability options.

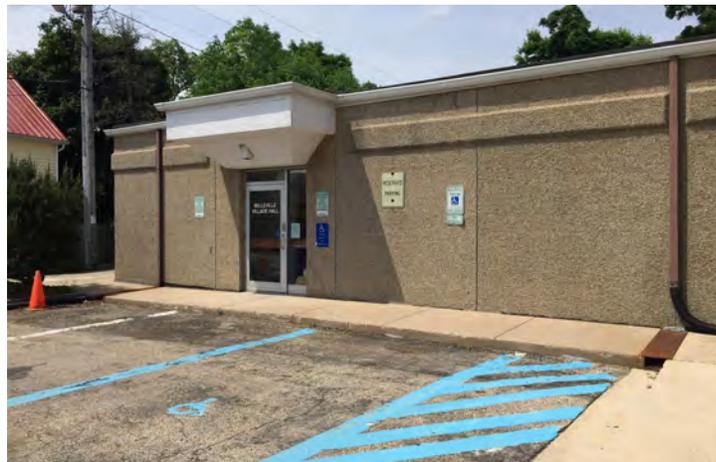
The rear door, near parking accessible parking, has a button for assistance. The curb cut at the accessible parking

parking should be updated and a lower threshold provided at the back door.

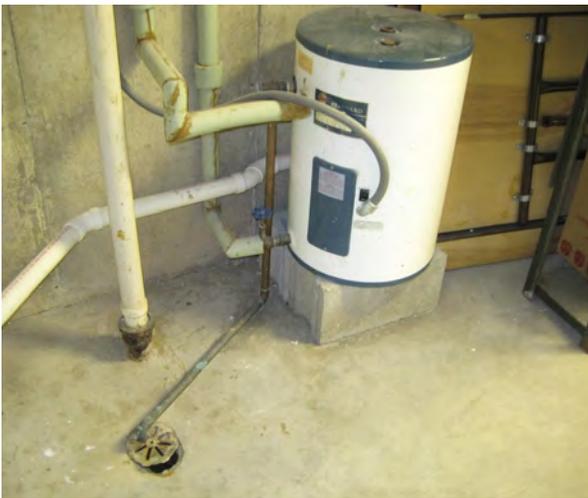
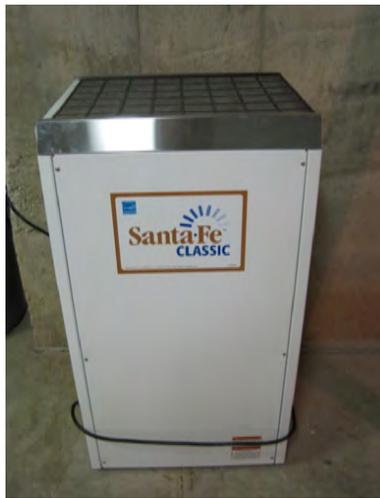
**PLUMBING SYSTEM WATER HEATER:** Domestic hot water is supplied from a 30 gallon electric storage type water heater, located in the basement level mechanical room. The domestic water heater does not have an expansion tank on the cold water supply line, which is required by code. Recommend adding expansion tank for existing system.

The installed water heater appeared to be in excellent condition.

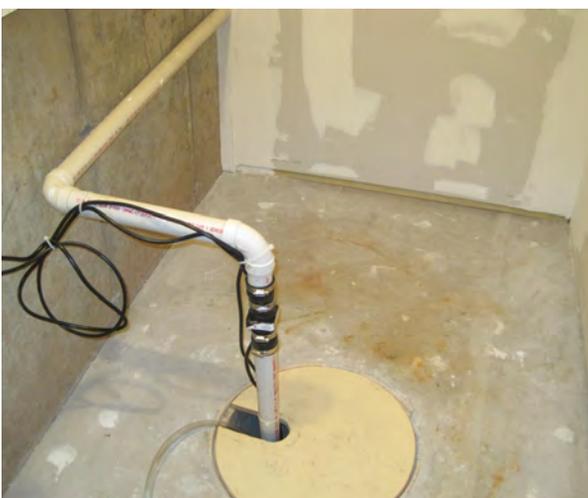
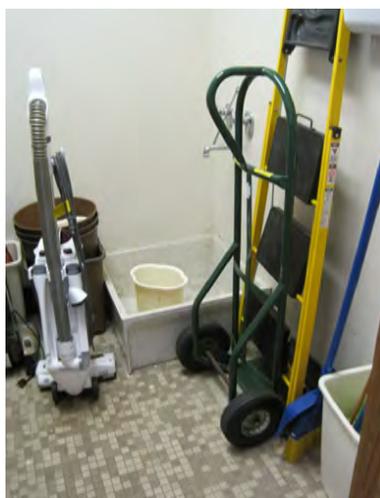
**PIPING SYSTEM DOMESTIC WATER:** Domestic water piping systems are to be copper with sweat fittings. Domestic hot water and cold water are insulated with closed-cell elastomeric insulation. The hot water system has no hot water recirculation line. These piping systems appear to be in good condition; however visual observations do not reveal potential internal issues. It is unknown if there are issues with this piping system, although the calcium deposits present at the backflow preventer could be indicative of hard water. It is recommended that a water analysis be

performed to determine water hardness and if a water softener should be considered.

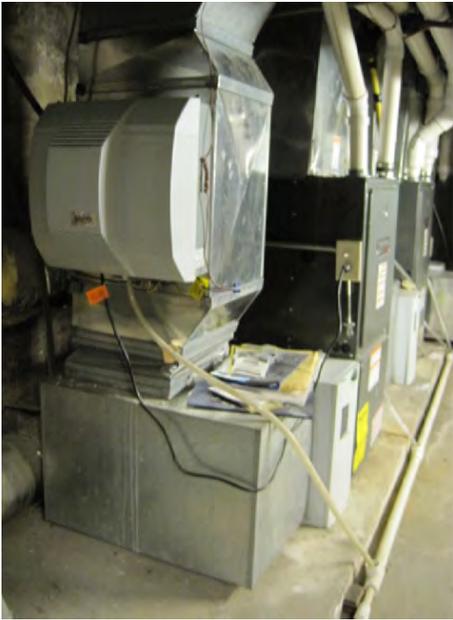
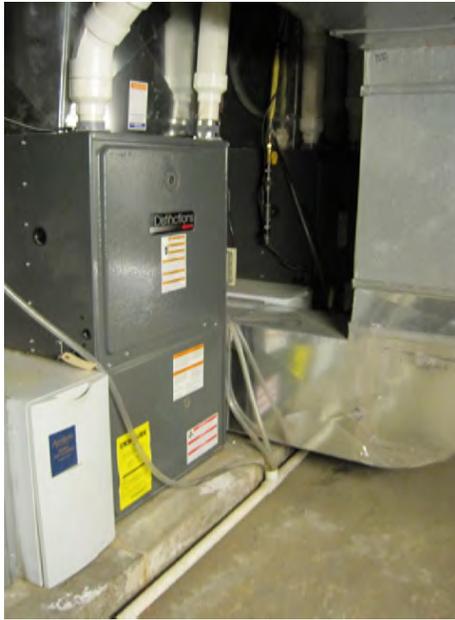
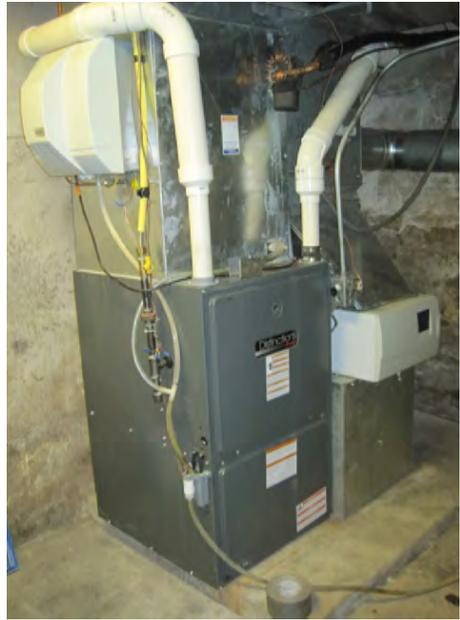
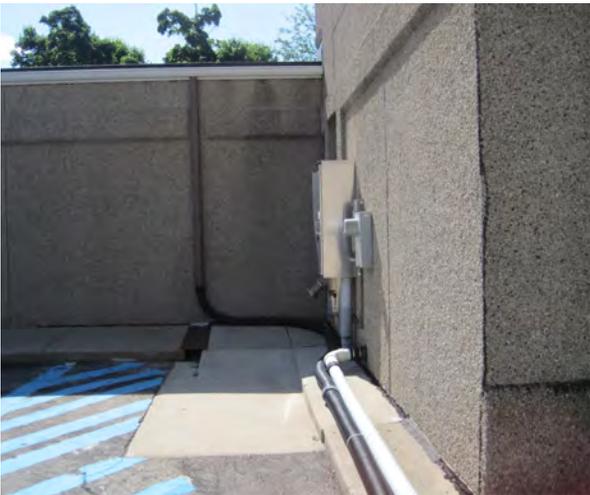
**HVAC SYSTEM AIR DISTRIBUTION SYSTEM:** The air distribution system to the spaces is served with four commercial furnaces by Amana Brand which provides the cooling and heating to Village Hall as well the support spaces. There are forced air system units to temper the air. Furnace output is approximately 98 MBH @ AFUE with a 98% high efficiency condensing unit. The heating mode has full modulation.

The fan system is a constant air supply to the space. Each furnace has 12" filters. The return air is a ducted return system. Each furnace has an Aprilaire humidifier with humidity stat in the return duct system. Dirty Ducts cleaned the system in 2013. Life expectancy of furnaces is 15-20 years depending on service, maintenance and changing filters. These furnaces were installed in 2004 and will support the building's needs. Recommend annual service checkups. The existing exhaust fan should have a regular inspection, the fan belt checked, and cleanliness tested for system operation expectancy.

It is recommended the supply and return air ducts be cleaned for indoor air quality improvement measure

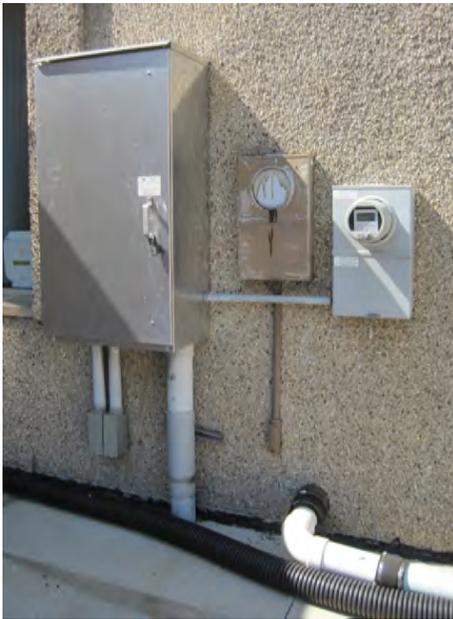
**ELECTRICAL SYSTEM INCOMING SERVICE:** Electrical service is provided to the Village Hall from Wisconsin Power & Light. Main service within the building is a 400 amp main distribution panel at 208 volts, three phase (refer to Main Service Board analysis below). Life expectancy of electrical equipment is 30 years. Existing boards and panels are approximately 20 years of age and should be thoroughly checked, cleaned, and tested for system operation expectancy.

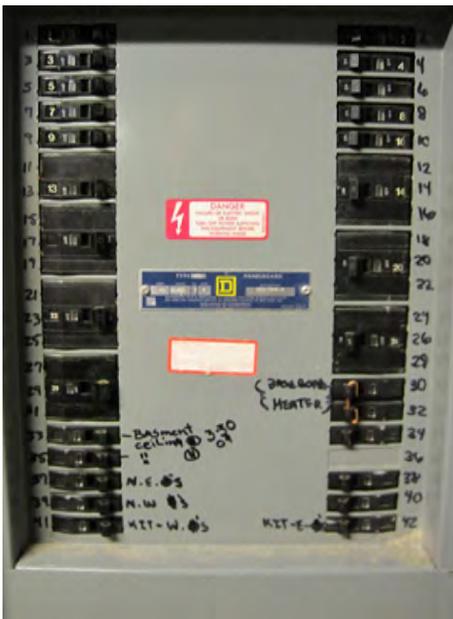
The main electrical service board (MSB) is a Square D distribution board rated at 208 volt, with a 400 amp main disconnect. Power feed distribution is a conduit feeder to Power Panel located on the first floor, and conduit feeder to Power Panel on the ground floor. Existing power load on existing Main Service Board is approximately 400 amps. Future expansion of the Village Hall would require a new amp service into the new expansion to accommodate new power loading to new plumbing equipment, mechanical equipment, technology equipment and power devices and junction boxes.

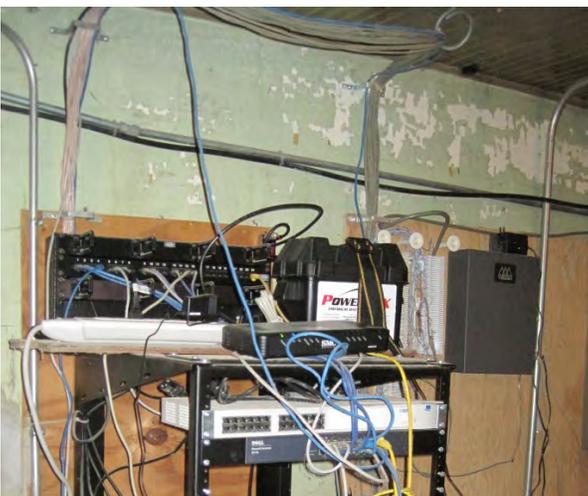
Technology head end equipment switches, hubs, server, firewalls and miscellaneous equipment (i.e. wireless routers) are located in the ground floor maintenance area. These devices are not in a dedicated Information Technology room. It is recommended that the Village Hall locate these items in a new, dedicated telecommunications room (TR) that is temperature controlled, secured and monitored.

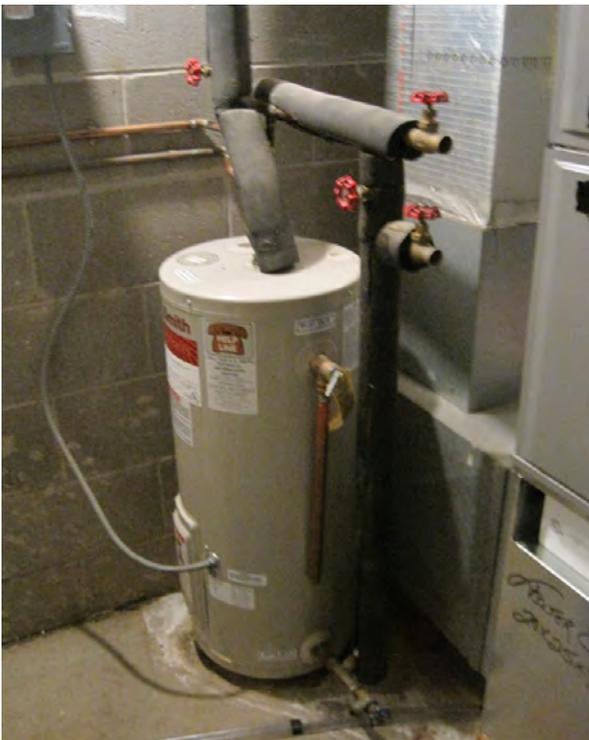
**PLUMBING SYSTEM DOMESTIC WATER:** Domestic water piping systems are to be copper with sweat fittings. Domestic hot water and cold water are insulated with closed-cell elastomeric insulation. The hot water system has no hot water recirculation line. These piping systems appear to be in good condition; however visual observations do not reveal potential internal issues. It is unknown if there are issues with this piping system, although the calcium deposits present at the backflow preventer could be indicative of hard water. It is recommended that a water analysis be performed to determine water hardness and if a water softener should be considered.

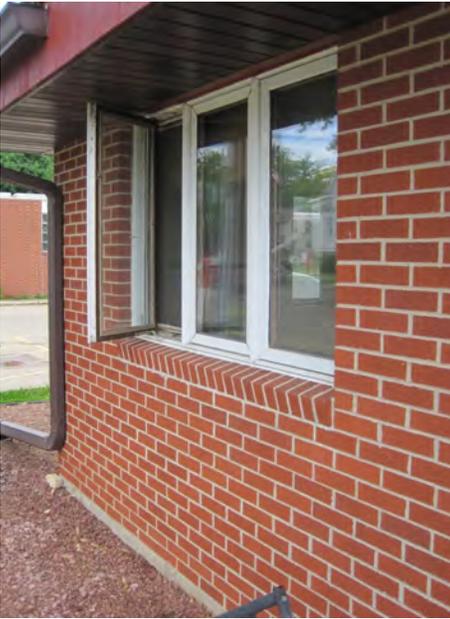
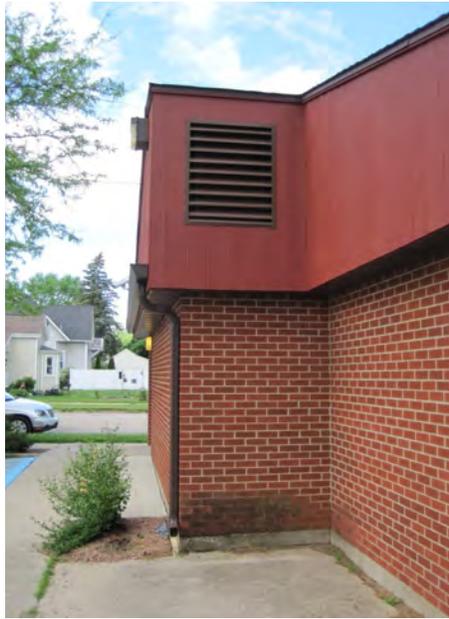
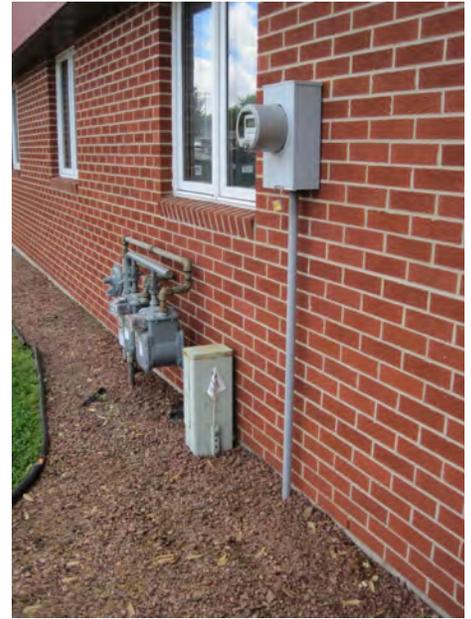
**PLUMBING SYSTEM STORM:** Storm drainage is accomplished by perimeter gutters and downspouts away from the building. These all appear to be in good condition.

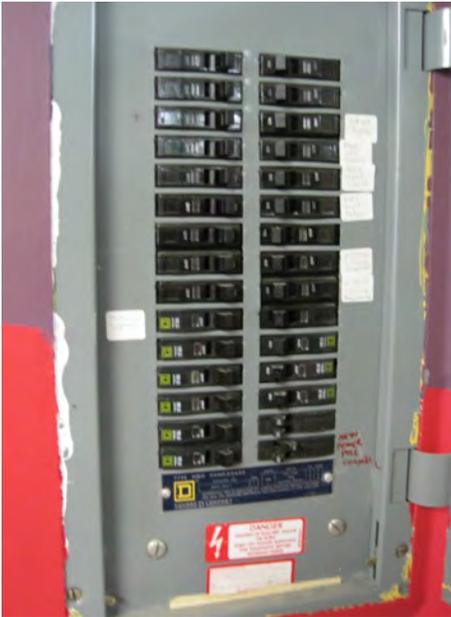
The ground floor power panel, Square D panelboard, is rated at 208 volt, 100 amp. All power to receptacle devices, and miscellaneous power junction boxes on the ground floor are fed from this power panel. HVAC loads are served by basement floor power panel. All breaker positions within the panel are in the "on" position, indicating that spare capacity does not exist within the panel. Expansion to the ground floor of existing library would require a new single-section 225 amp power panel.

The power panel will have to be metered for verification of existing loading to panel from existing power devices and equipment prior to utilization of spare breakers. A new 100 amp single section power panel power panel may have to be installed for a larger expansion of the existing Library.

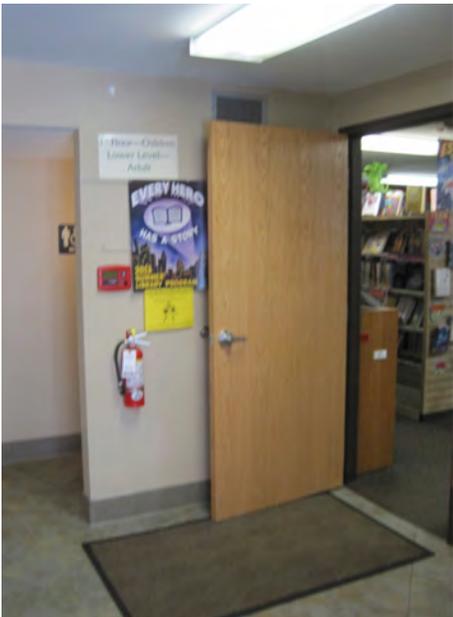
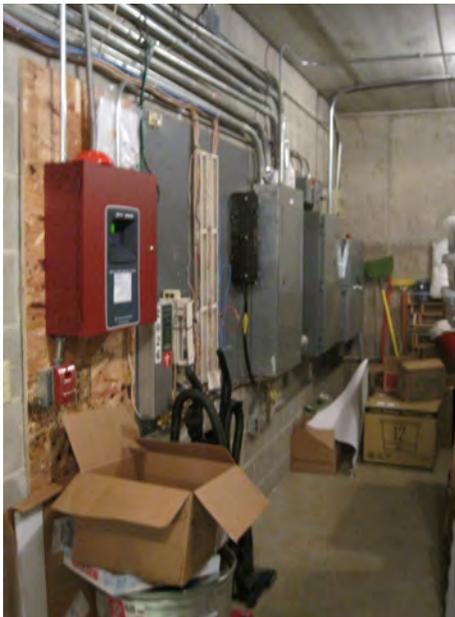
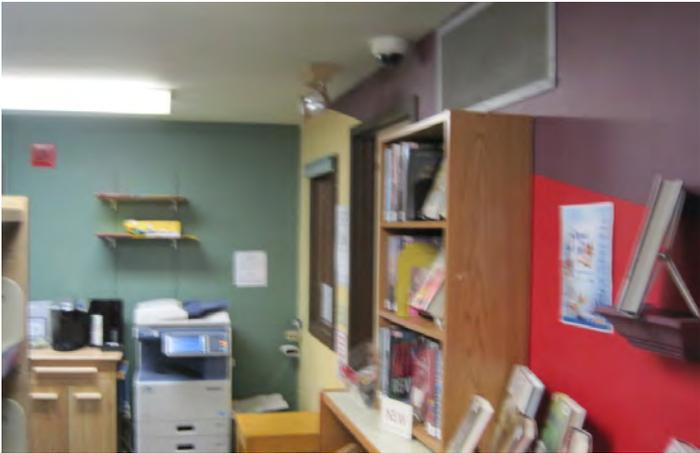
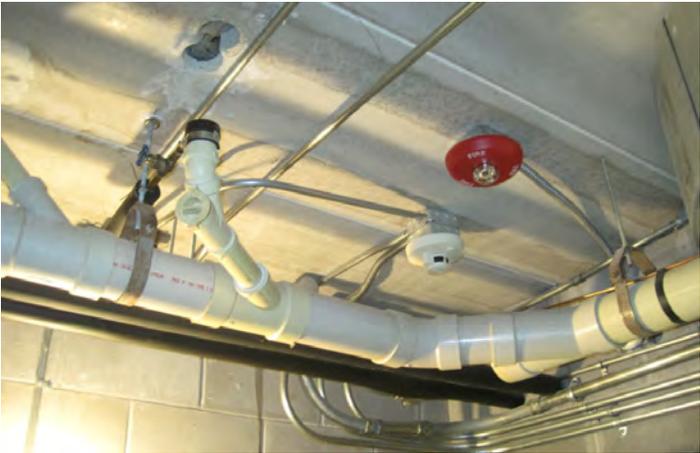
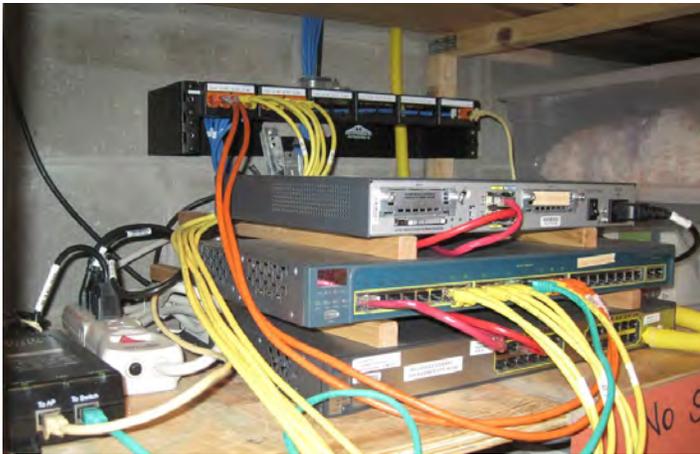
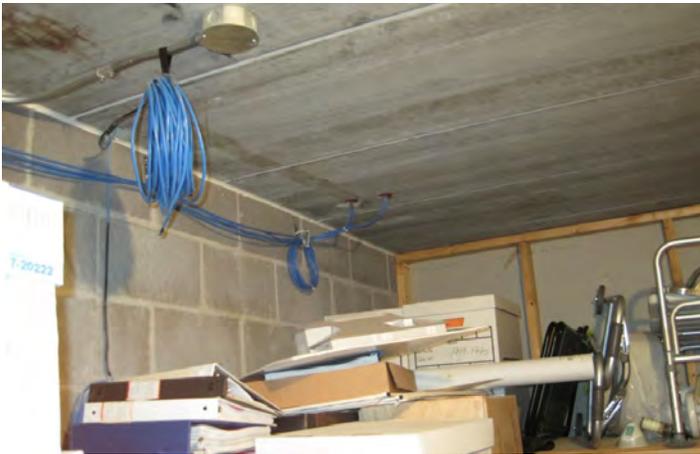
**FIRE ALARM SYSTEM:** Building has recently installed a fire alarm system which has pull stations, notification devices and smoke detection devices. Fire alarm panel is located in the main electrical room with a remote annunciator panel in the lobby area. The circulation spaces, storage areas, and mechanical spaces have smoke detection. There are fire pull stations at egress path areas. The fire alarm has visual notification and audible for emergency exiting. There are also fire extinguishers in the building.

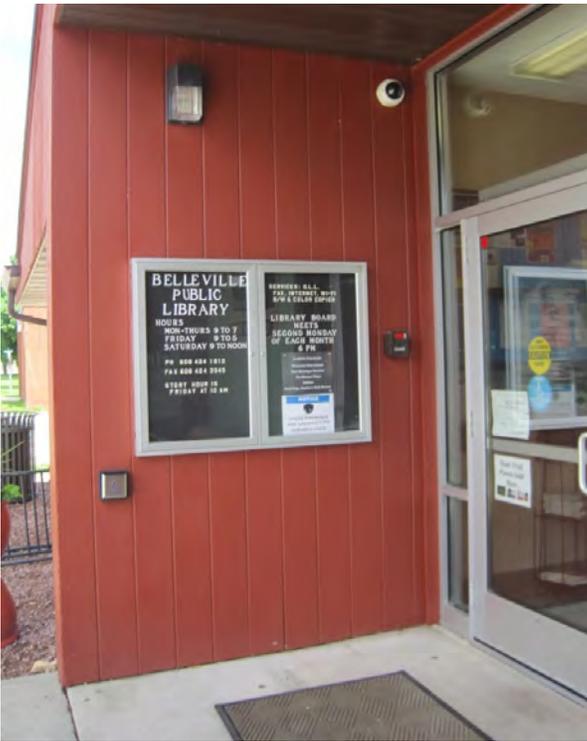
**SECURITY - ACCESS CONTROL DEVICES:** Existing access control devices consist of door alarms connected to monitor console at the Librarian Desk, controlled by keyed operation. Power at console is 120 volts fed from the first floor power panel. A new access control and CCTV system (see below) or an extension of the existing access control and CCTV system at entry/exit points to and from the building due to expansion will be required. Power for new access control and CCTV head-end equipment would derive from spare capacity in power panel or from a new first floor power panel. It is recommended that all security equipment be located in the TR with the other network equipment. This will secure the equipment and simplify system integration.

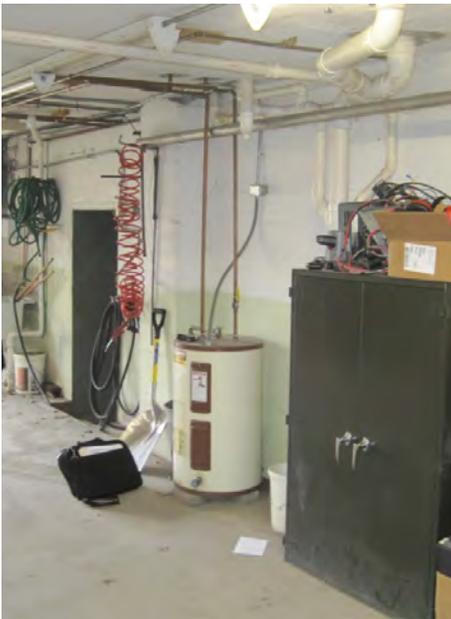
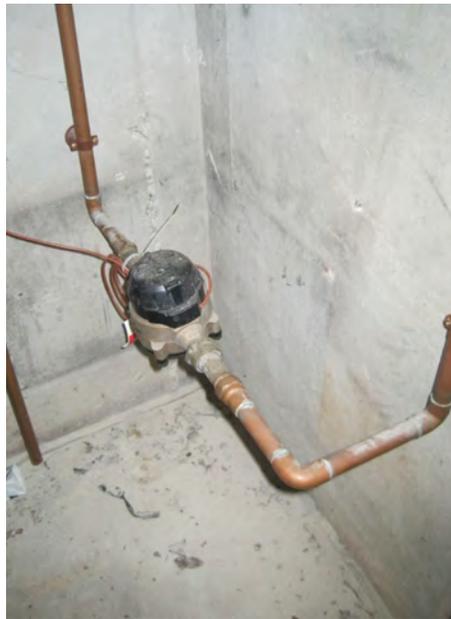
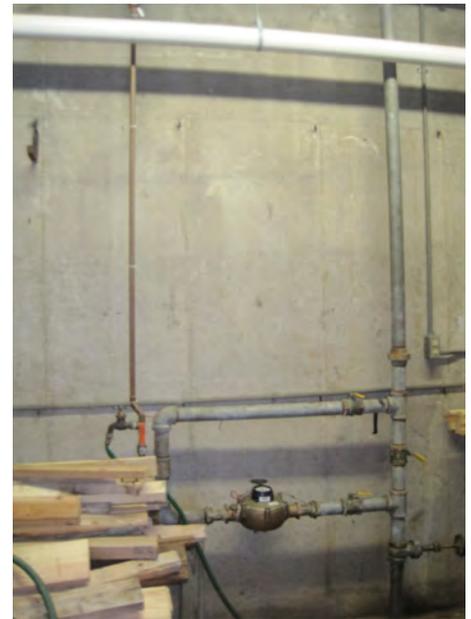
**PLUMBING SYSTEM WATER HEATER:** Domestic hot water is supplied from a 30 gallon, electric storage type water heater, located in the basement level mechanical room. The domestic water heater does not have an expansion tank on the cold water supply line which is required by code. Recommend adding expansion tank for existing system.

The installed water heater appeared to be in excellent condition.

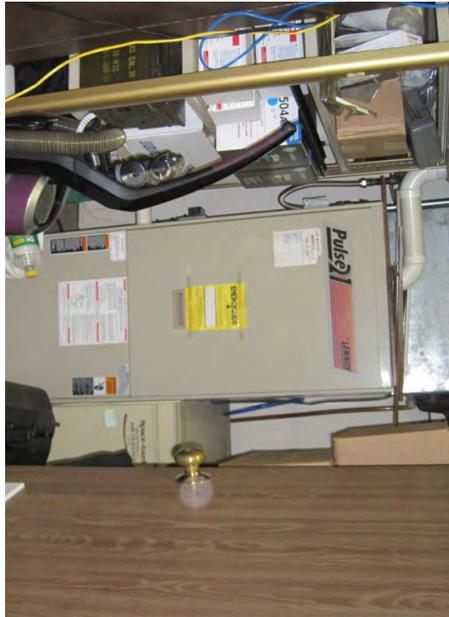
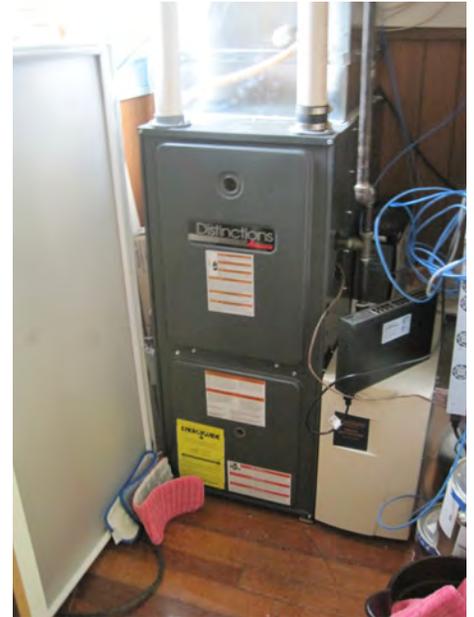
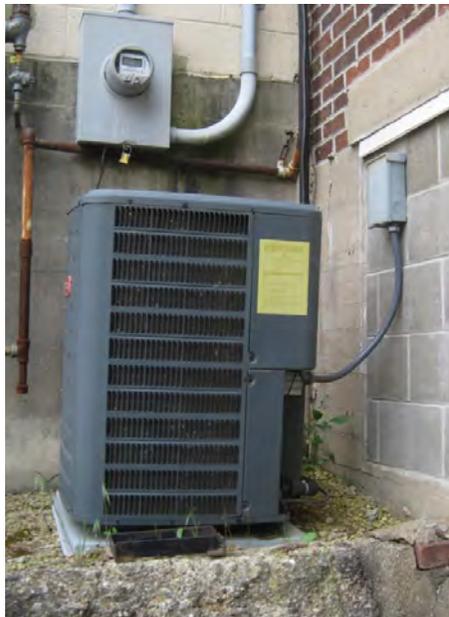
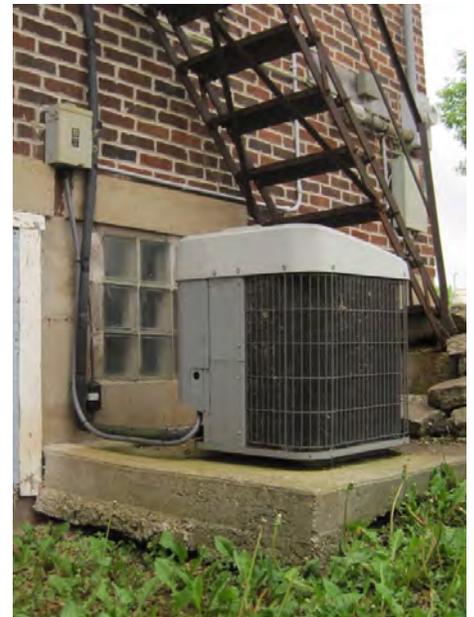
**HVAC SYSTEM AIR DISTRIBUTION SYSTEM:** The air conditioning system consists of two air-cooled condensing units manufactured by Tempstar and Goodman that are located outdoors along the north side of the building. These are 2 and 3 Ton units installed with the furnaces with R-22 refrigerate with SEER 13. The refrigeration compressor provides the level of single staging of the cooling to the overall HVAC systems. The cooling system appears to be good working condition.

Life expectancy of outdoor equipment is 10-12 years depending on service and maintenance. Recommend annual service checkups. The outdoor units should be regularly inspected for cleanliness and tested for system operation expectancy.

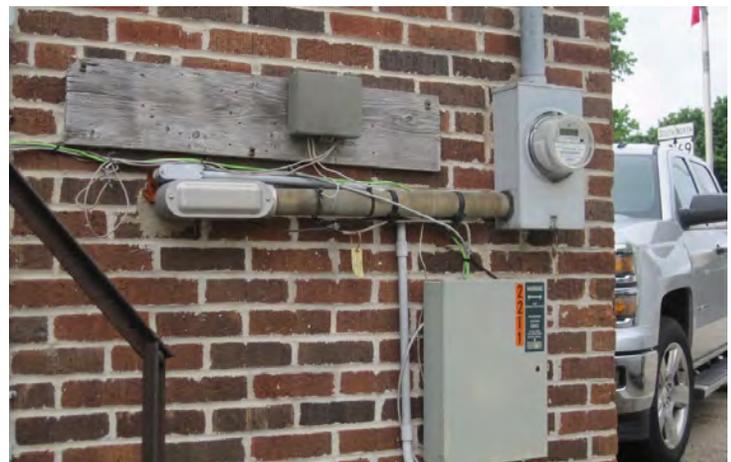
The main electrical service board (MSB) is a Square D distribution board rated at 208 volt, with a 200 amp main disconnect. Power feed distribution is a conduit feeder to Power Panel located on the Main floor and conduit feeder to Power Panel on the Upper floor. Existing power load on existing Main Service Board is approximately 200 amps. Future expansion of the Police Station would require a larger electrical service into the new expansion

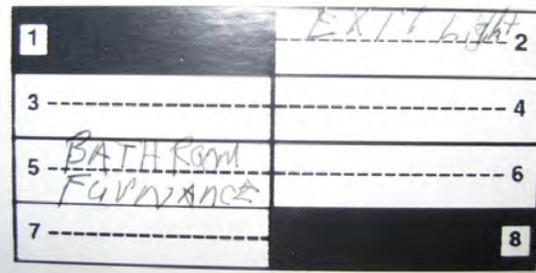
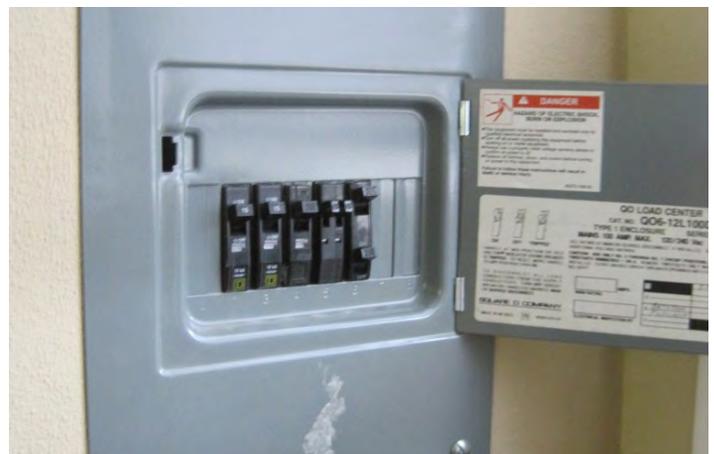
The ground floor power panel, Square D panelboard, is rated at 208 volt, 100 amp. All power to receptacle devices, HVAC loads and miscellaneous power junction boxes on the ground floor are fed from this power panel. All breaker positions within the panel are in the "on" position, indicating that spare capacity does not exist within the panel. Expansion to the ground floor of existing Police Station would require a new single-section 225 amp power panel.

The power panel will have to be metered for verification of existing loading to panel from existing power devices and equipment prior to utilization of spare breakers. A new 225 amp single section power panel may have to be installed for a larger expansion of the existing Police Station.

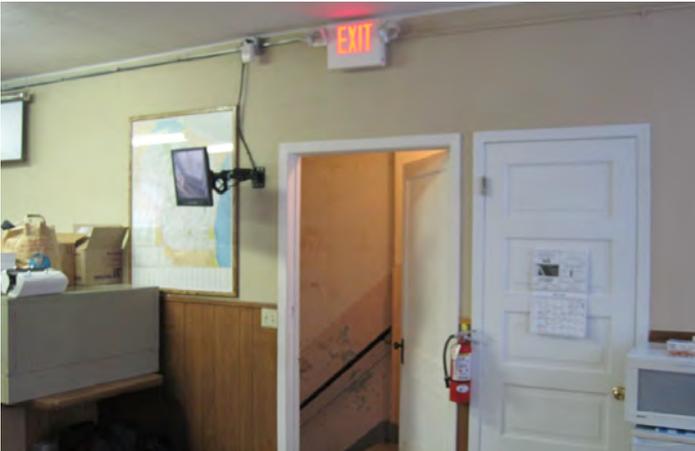
**FIRE ALARM SYSTEM:** It's our understanding the building doesn't have a central fire alarm system for monitoring and reporting. The Police Station may wish to consider providing a fire alarm system at a few important storage locations, lower level, and other strategic locations. There are fire extinguishers and non-system smoke detector devices in the building at key areas.

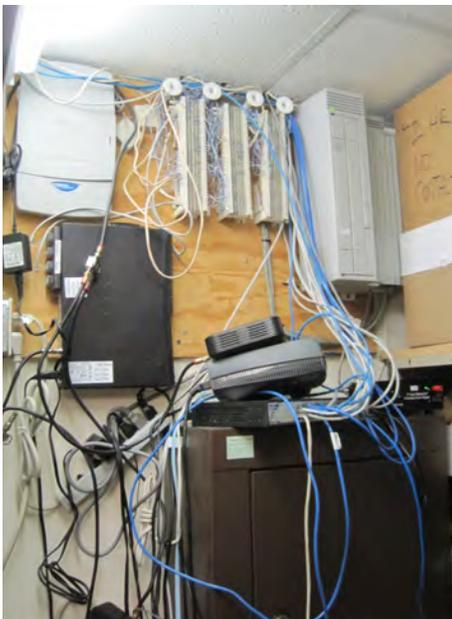
Technology head-end equipment switches, hubs, server, firewalls and miscellaneous equipment (i.e. wireless routers) are located in the ground floor maintenance area. These devices are not in a dedicated Information Technology room. It is recommended that the Police Station locate these items in a new, dedicated telecommunications room (TR) that is temperature controlled, secured and monitored. There is definitely a space need or dedicated space for all the Technology used in the Police Station. Furnace rooms are not desirable spaces.

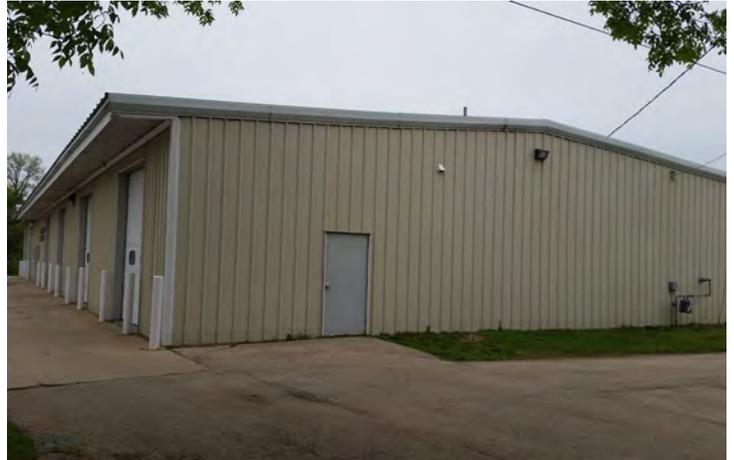
The public works building, pictured, was built in 1973 and purchased by the Village in 1989. It received a new roof in 1992 and new partial siding in 1994. The building is a single-story metal building with metal siding and a metal-clad gable roof. The existing building footprint is 9,853sf with a site of 47,219sf (1.084 acres). No formal parking spaces are marked, but space is available in the front and back of the site for vehicles.

The building itself is basic and does not have significant interior or exterior items that would require attention.

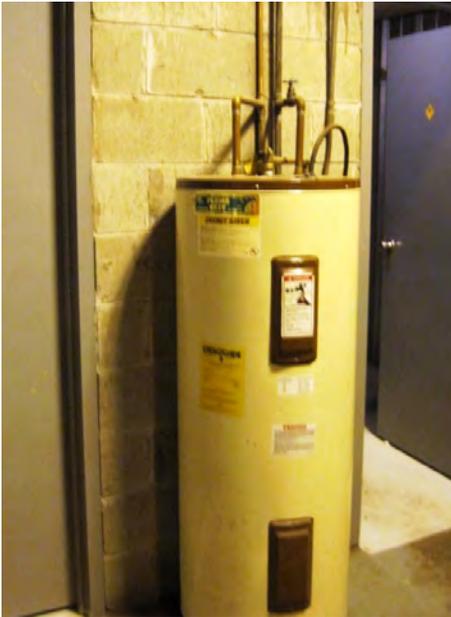
**PLUMBING SYSTEM WATER SERVICE:** The main water service entrance is a 1" size pipe and enters the North end of the Basement Level of the building. A reduced pressure backflow preventer and building water meter are located at this entry point.

**PLUMBING SYSTEM WATER HEATER:** Domestic hot water is supplied from a 50 gallon electric storage type water heater, located in the basement level mechanical room. The installed water heater appeared to be in reasonable condition. The domestic water heater does not have an expansion tank on the cold water supply line, which is required by code. Recommend adding expansion tank for existing system. One safety shower is not adequate for the size of this facility and potential level of hazard that may occur. By code, safety showers require unit piped by a temper water system using mixing of hot and cold water.

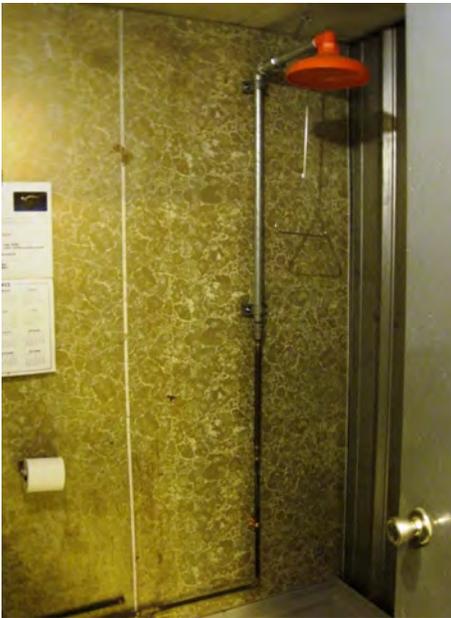
**PLUMBING SYSTEM DOMESTIC WATER:** Domestic water piping systems are to be copper with sweat fittings. Domestic hot water and cold water are not insulated. The hot water system has no hot water recirculation line. These piping systems appear to be in not adequate condition; however visual observations do not reveal potential internal issues. It is unknown if there are issues with this piping system, although the calcium deposits present at the backflow preventer could be indicative of hard water. It is recommended that a water analysis be performed to determine water hardness and if a water softener should be considered.

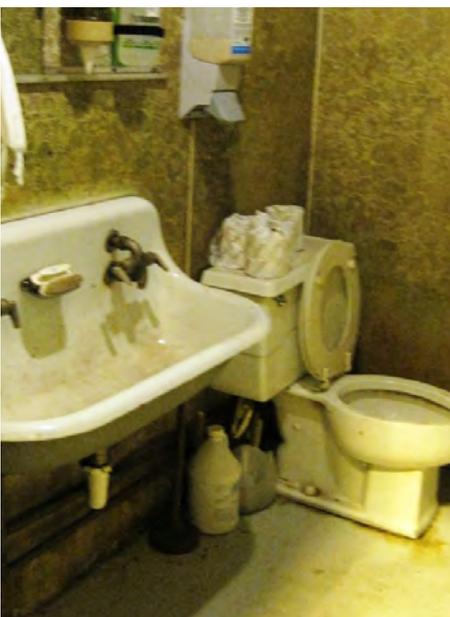
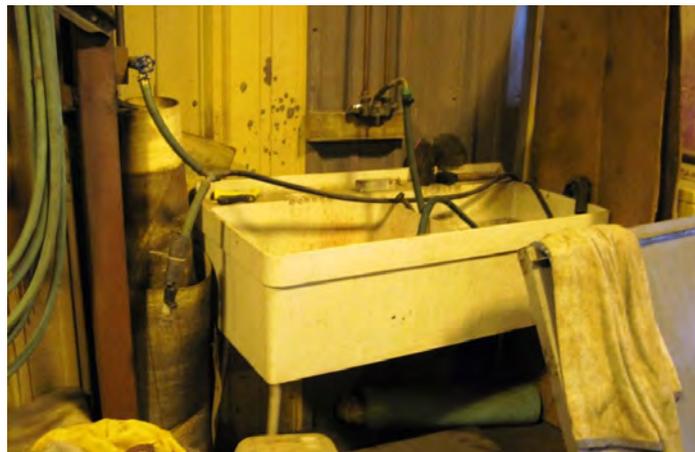
**PLUMBING SYSTEM PLUMBING FIXTURES:** Plumbing fixtures are vitreous china or stainless steel and appear to be in very poor condition. Their restrooms have not been remodeled since Village of Belleville has moved into the building.

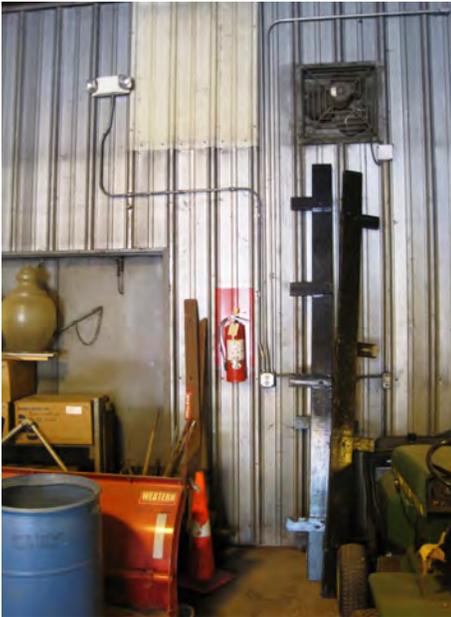
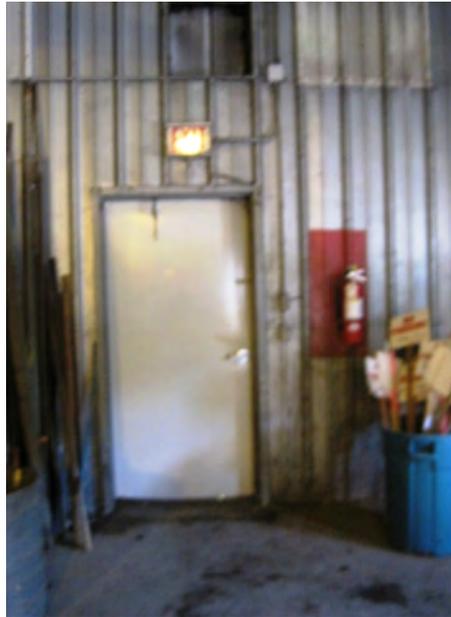
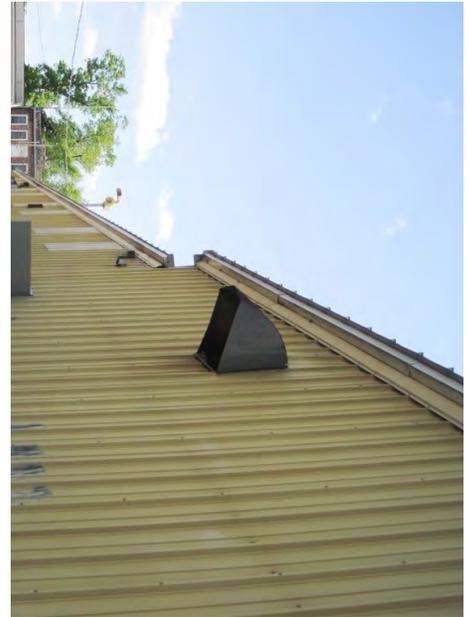
**HVAC SYSTEM WIRING AIR DISTRIBUTION SYSTEM:** The air distribution system is very minimal. The Public Works facility is exhaust driven spaces to ventilate and purge the building. All of these exhaust fans are original and may not adequate work. The toilet exhaust has been removed. Recommend replacing these exhaust fans to proper ventilate and purge the building. The exhaust fan should have a regular inspection, the fan belt checked, and cleanliness tested for system operation expectancy. The offices and support spaces require ventilation and recommend having a dedicated makeup air unit.

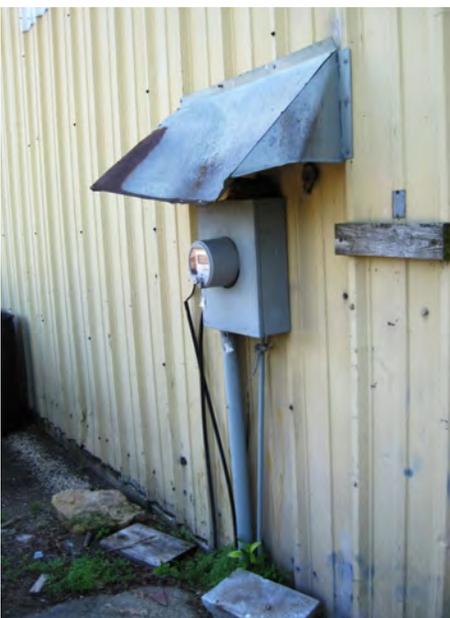
The main electrical service board (MSB) is a Square D distribution board rated at 208 volt, with a 200 amp main disconnect. Power feed distribution is a conduit feeder to Power Panel located on the first floor, and conduit feeder to Power Panel on the ground floor. Future expansion of the Public Works would require a new large electrical service into the new expansion to accommodate new power loading to new plumbing equipment, mechanical equipment, technology equipment and power devices and junction boxes.

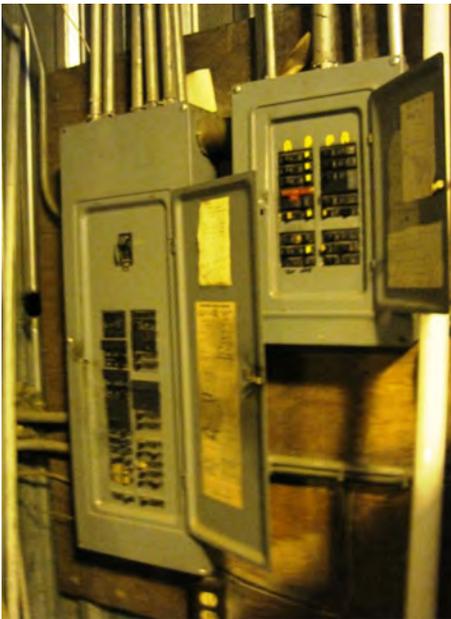
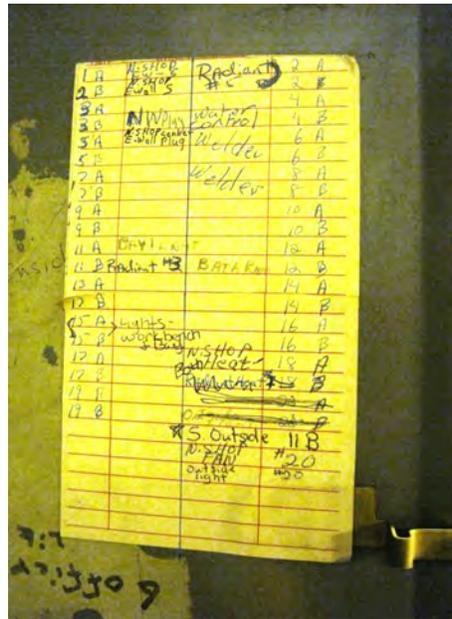
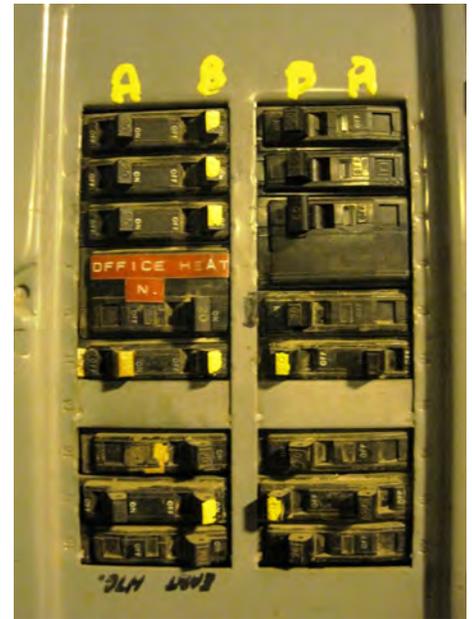
The Main power panel, Square D panelboard, is rated at 208 volt, 200 amp. All power to receptacle devices, HVAC loads and miscellaneous power junction boxes on the ground floor are fed from this power panel. All breaker positions within the panel are in the "on" position, indicating that spare capacity does not exist within. Expansion to the main floor of the existing Public Works facility would require a new single section 225 amp power panel.

The power panel will have to be metered for verification of existing loading to panel from existing power devices and equipment prior to utilization of spare breakers. A new 200 amp single section power panel power panel may have to be installed for a larger expansion of the existing Public Works facility.
